Alston Conservation Area Character Appraisal and Management Plan

March 2023

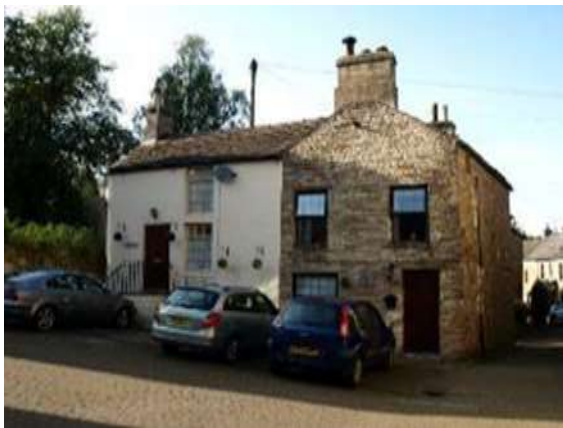
Figure 8 Building clusters in the medieval core

4.2.1 The town evolved organically adapting to the uneven topography, resulting in a cramped piecemeal and eclectic development of plain and functional character. The medieval layout is clearly visible around Front Street and the Butts areas, with characteristic clusters of buildings laid around the Parish Church and narrow streets and ginnels. The later developments from the 18th, 19th and early 20th century tend to be linear along Townfoot, Townhead and Nenthead Road, but no buildings are the same, indicating the absence of planned development within the conservation area.

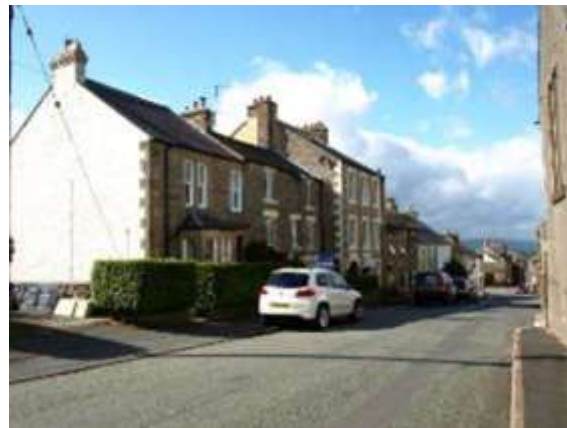
Figure 9 Piecemeal linear development along main roads

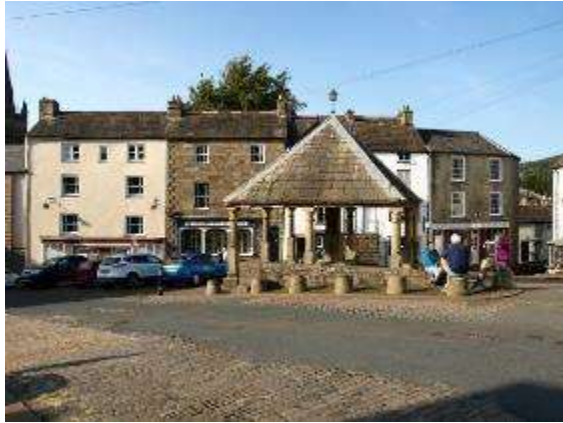
Figure 10 Plain character of buildings on Market Place

4.2.2 Buildings in the conservation area are usually of plain character with little embellishments such as finials, kneelers, mouldings etc., with some notable exceptions, mainly on institutional buildings. Traditional facades are usually flat as historic bay windows, oriel bays, or dormers are rare. Only recessed windows and doors frames, and/or protruding stone detailing provide some depth to front elevations. Rear elevations are utilitarian in character and opening arrangements are usually random. Roofs are in the main dual-pitched, with some gable ends facing the street, and eaves tend to be flush to walls. Stone chimneys are still a prevalent feature on historic buildings but many have been replaced with a brick or cement render finish. Buildings tend to be several storeys high, reaching their highest around Market Place. Combined with a cramped layout, giving a sense of enclosure.

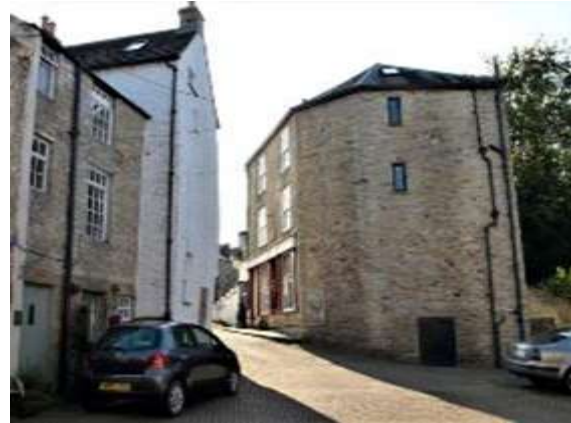
Figure 11 Towering buildings, random opening arrangements and flush eaves to walls in the Butts area

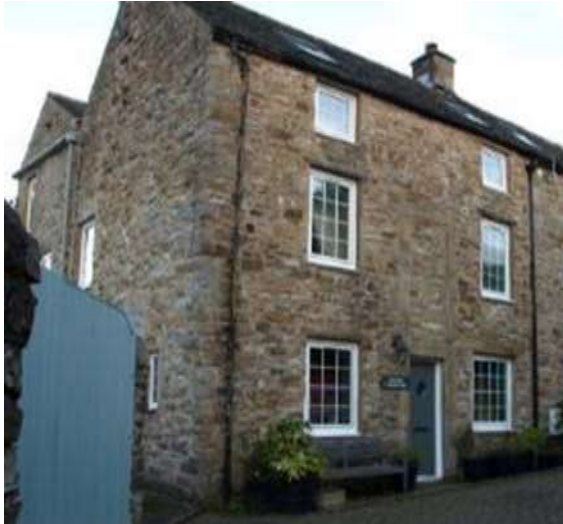
Figure 12 Blocked first floor opening and external stairs removed

- Re-building random rubble stone walls with coursed or snecked stone⁵, and more rarely ashlar⁶
- Introduction of symmetry or proportion in the arrangement of openings, and blocking of older openings
- Enlargement of windows and insertion of timber sashes, addition of classical door surrounds
- Alteration of storeys
- Removal of external stairs
- Rendering of the front elevation, either with a roughcast or stucco imitating a stone ashlar⁷ and lime washed⁸
- Insertion of timber shopfronts and large glass windows
- Replacement of sandstone roof flags from the 19th century with Welsh slate

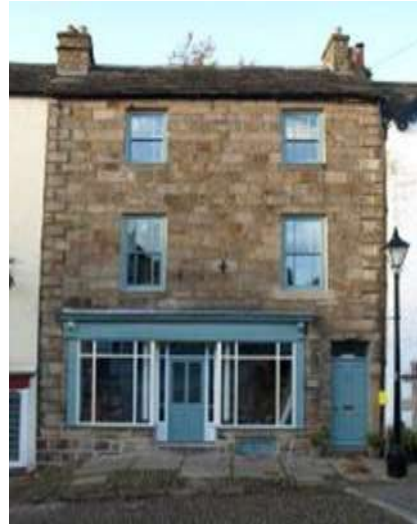
Figure 13 Ashlar re-facing, wide and symmetrical windows and shopfront

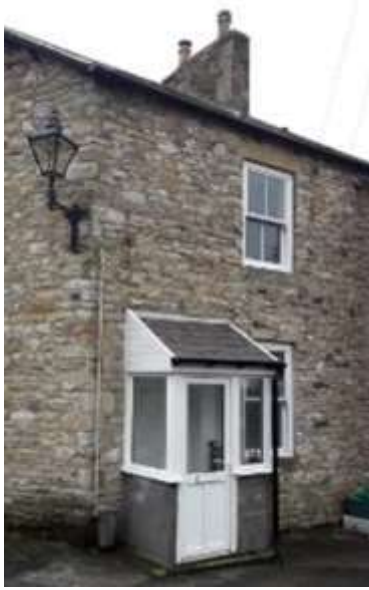
Figure 14 Modern porch

1. - Some loss of features such as shopfront detailing and traditional timber sashes replaced by replacement UPVC windows and doors
2. - Addition of dormers, porches, bay windows, canopies over front doors with a design often out of keeping
3. - Installation of modern shop signage on historic shopfronts
4. - Application of cement renders and masonry paints, or on the contrary removal of historic finishes to expose stone walls
5. - Installation of grey satellite dishes, metal aerials and replacement of cast-iron rainwater goods with UPVC

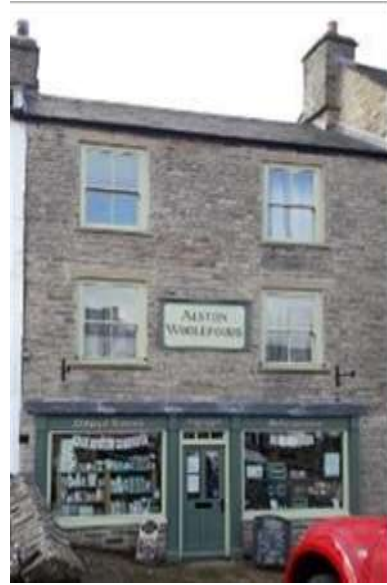
Figure 15 Restored shopfront

However, several shopfronts and front elevations have since been restored to their historic design thanks to the THI scheme.

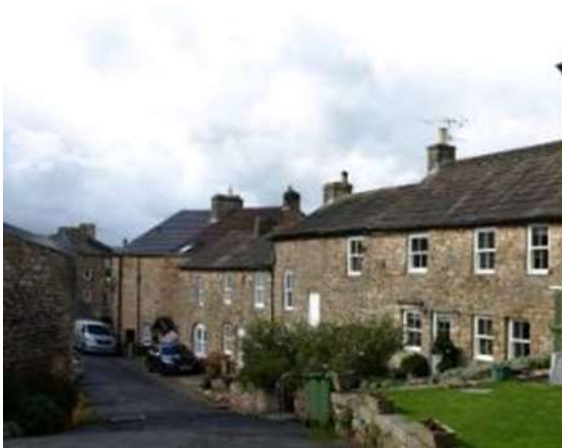
Figure 18 Stone walls and roofs

- 4.2.7 The predominant traditional material for wall and roof construction is the local sandstone, which gives the area its unique character. There are a few exceptions with walls of brick or with a different stone. Half of the buildings have now Welsh slate roofs, which became popular following the arrival of the railway in the 19th century. Several buildings retain a historic lime roughcast render or stucco finish, but there are also many cement renders and masonry paints.

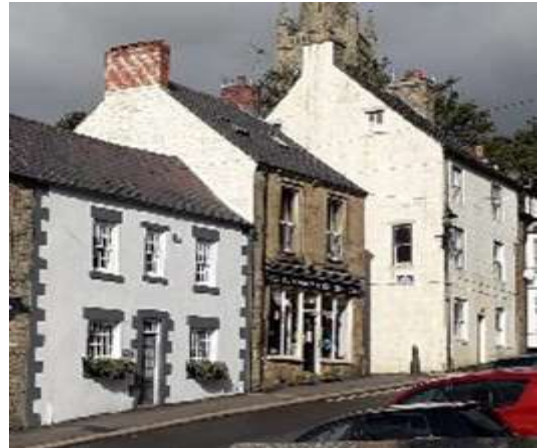
Figure 19 Historic stucco finishes

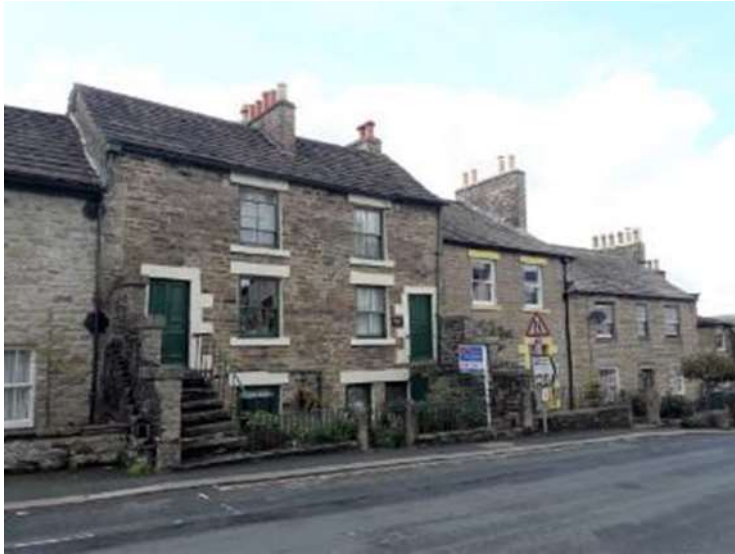
Figure 20 Painted stone detailing

- 4.2.8 Apart from traditional shopfronts, stone detailing and frames painting, the colour palette in the area is relatively restrained, with grey or brown/buff for stone walls and roofs, grey-brown sandstone flags and dark blue for slate roofs, and white, off-white, grey, beige or light pink for renders and paints. It is not known whether historic paints had a wider range of colours. There are still many surviving cast-iron rainwater goods. Rare leaded windows survive, but the majority of traditional windows and doors are in timber. There is however, a trend towards replacing timber frames with uPVC, eroding the traditional character of the area.

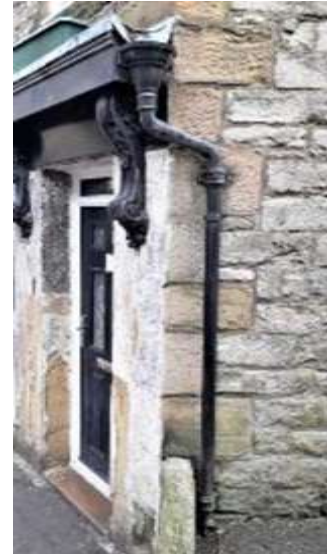
Figure 21 Cast-iron hopper and downpipe

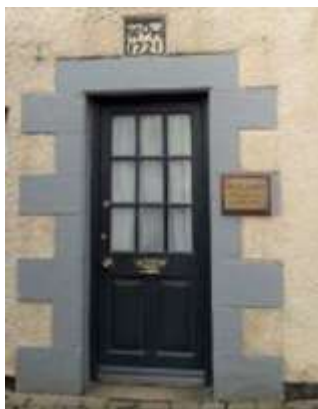
Figure 22 Rusticated door surround

⁹ Rusticated: type of architectural frame surrounding an opening where rectangular blocks stick out at intervals, usually alternating to represent half the surround.

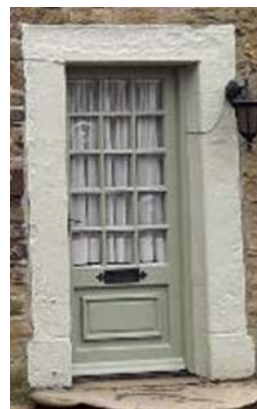
Figure 23 Monolithic door surround

¹⁰ Type of architectural frame surrounding an opening resembling a monolith

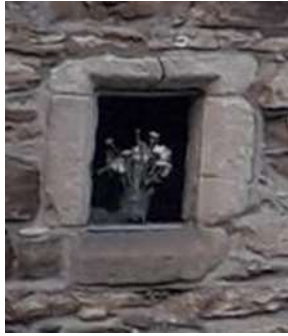
Figure 24 Fire window

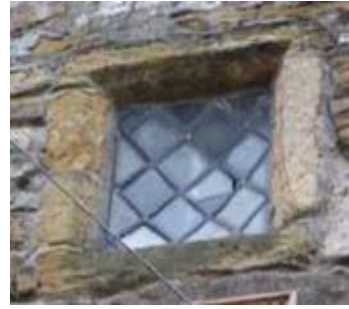
Figure 25 Chamfered window with leaded lights

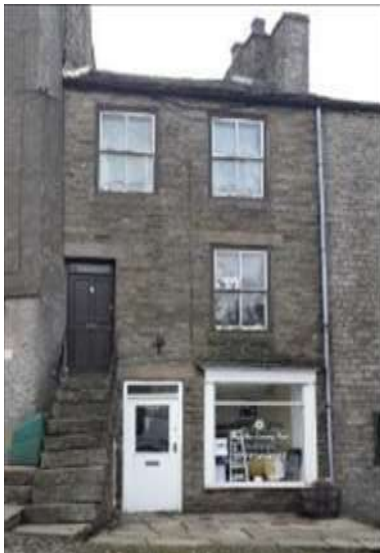
Figure 28 First floor entrance and panelled door

- Doors: first floor entrances accessed by external stone steps, usually with store under stairs; timber frames; plank or panelled style;

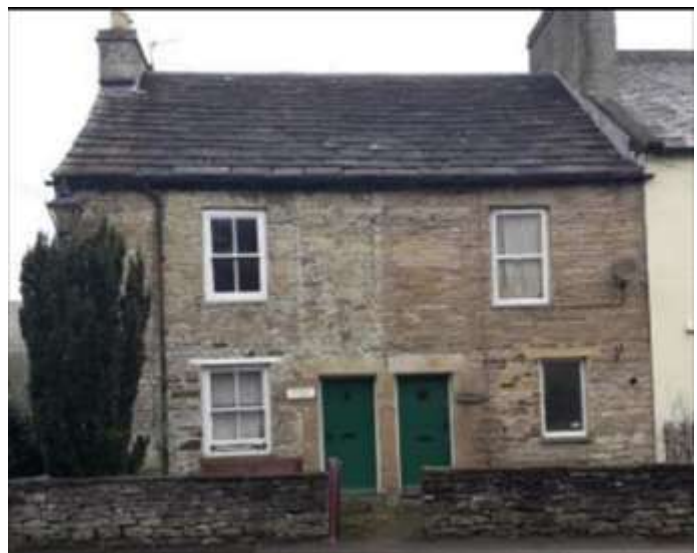
Figure 29 Timber plank doors

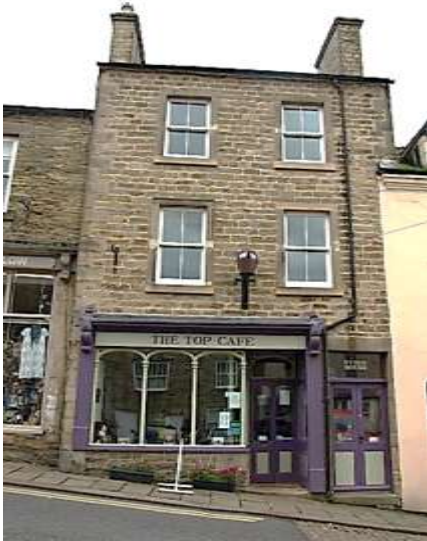
Figure 30 Integrated shopfront

- Shop fronts: mostly integrated within the front wall but some examples constructed as bays; timber frames with mullions, columns or finials dividing large vertical windows;

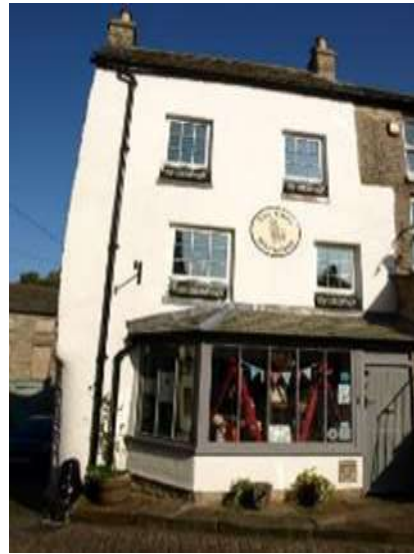
Figure 31 Bay shopfront

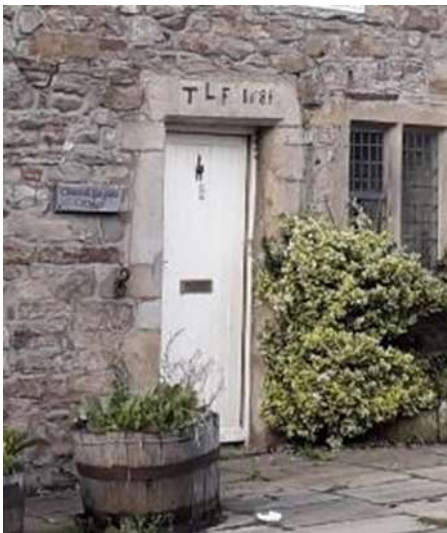
Figure 32 Date stone

- Other features: date stones; horse-shoe-shaped boot scrapers within walls;

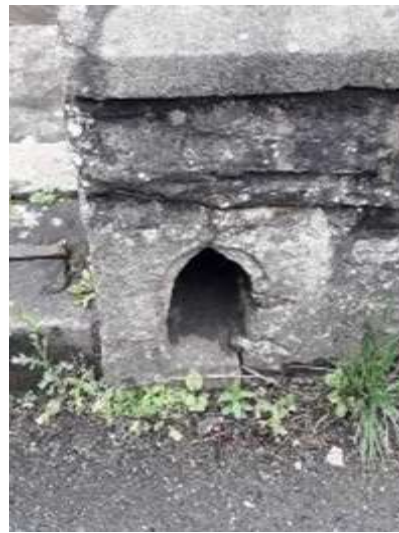
Figure 33 Boot scrapers

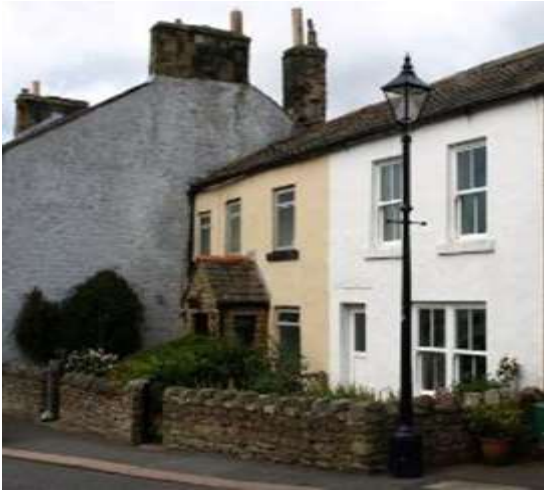
Figure 34 Rubble garden wall with saddleback coping stones

- Gardens and boundaries: rubble stonewalls with saddleback copping stones; timber plank garden and alleyway doors, cast-iron gates with plain stone posts.

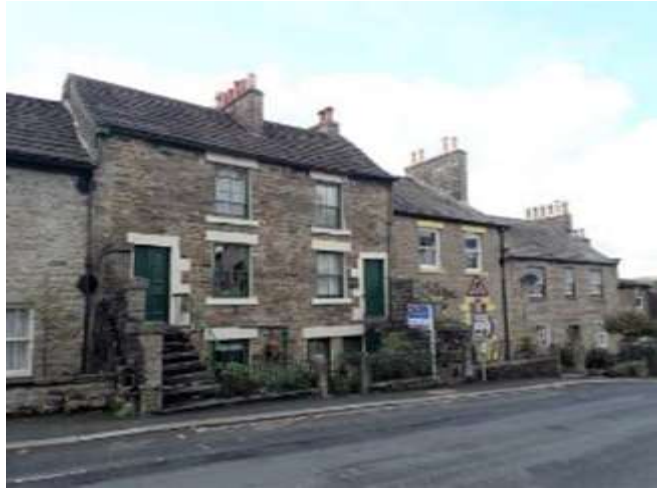
Figure 35 Cast iron railings and gate with plain stone posts

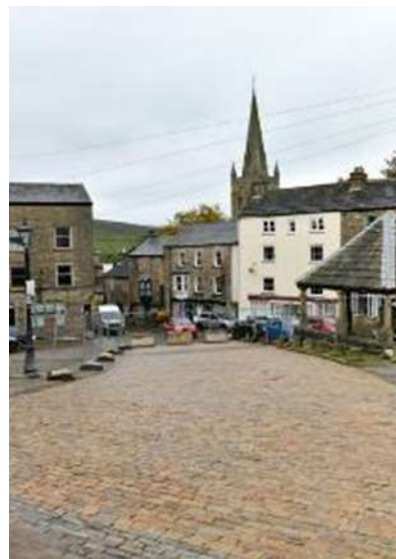
Figure 39 Reinstated cobbles

4.2.10 The cobbled Market place and the Potato Market are both hard standing open spaces of traditional character, but their historic quality have been eroded by insensitive development, parking, and tarmac surfacing replacing the original sandstone setts on Front Street. A section of setts across the Market Place has however been reinstated in the summer 2021. A few yards and lanes or ginnels also retain traditional sandstone setts, contributing to the historic character of the area. In contrast, the rest of the roads in the area are tarmacked and there are a few hardstanding areas of poor quality, such as tarmacked parking spaces and drives.

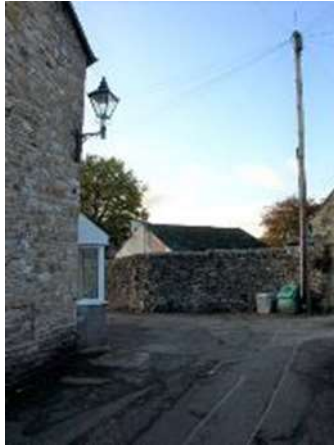
Figure 44 Wall mounted lantern and electric lines

- Utilities: historic cast iron lampposts or wall-mounted lanterns (painted black) but a few modern aluminium lampposts too; modern timber telephone/electric poles and lines cutting across streets, collection of historic cast-iron 'pants', or standpipes;

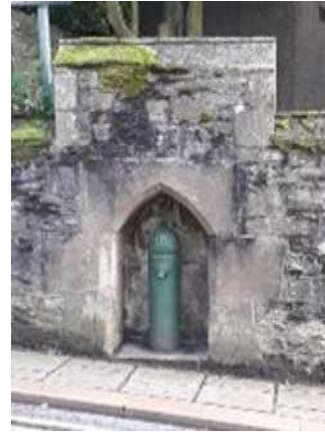
Figure 45 Standpipe

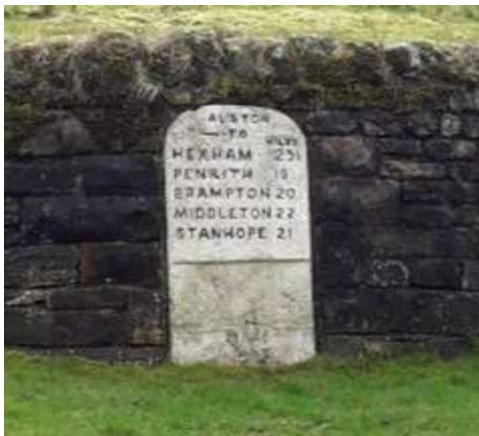
Figure 46 Grade II Listed milestone

- Signage: historic milestone (Town Hall grassed bank), uncoordinated road signage with a mix of traditional black and white direction signs and black and gold plaques, modern large promotional tourism board, timber footpath signs and large modern metal road signs sometimes obstructing views of buildings;

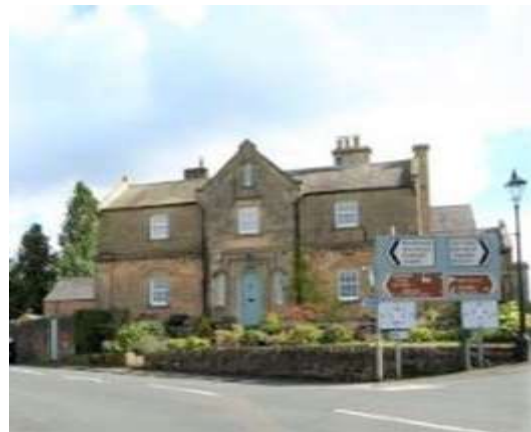
Figure 47 Modern road signs obstructing view of former Police Station building

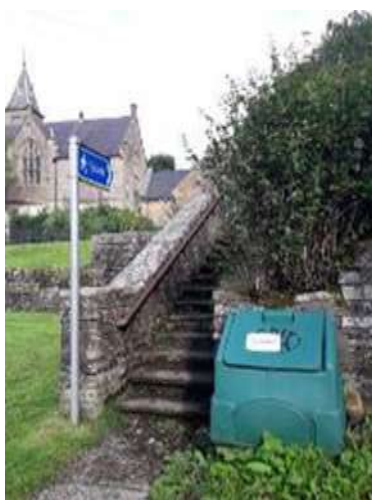
- Miscellaneous: usually discreet and well designed, with metal black bins metal painted bollards, stone benches, red royal mail post boxes, flower planters; however plastic green grit salt bins are less attractive

Figure 50 Modern salt bin

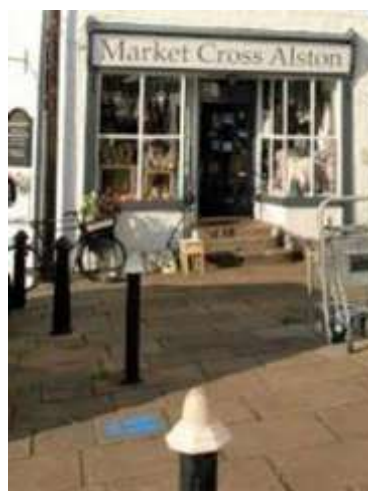
Figure 51 Traditional metal bollards

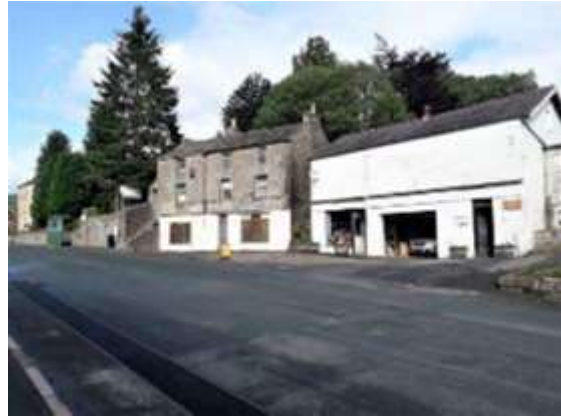
Figure 55 Former Tyne Café (left)

- 4.3.3 The former Tyne Café is the first building of the character area from this approach. This 18th century three-storey rubble stone building has architectural interest, with its house-over-byre layout and dressed stone detailing. However, its derelict condition reflects poorly on the conservation area. Adjoining is the Alston House Hotel, a grand three-storey former gentleman's residence converted into a hotel in the 20th century, with its 18C ashlar central frontage and large elevated front garden, and the early 20th century Cumberland Hotel in painted brick opposite. These hostelryes reflect the status of the road as a main thoroughfare. The former Bluebell Inn further down, also with an 18th century ashlar frontage, had been used as an inn from the 19th century but has been vacant for a decade. The 19th century OS maps shows that a further inn, the Golden Lion, stood opposite Alston House on a plot, which is now the latter's tarmacked car park. The hotel's car park and front garden provides a fortuitous open view on the town's dense built frontage beyond and to the right, and the green playing field and moors to the left.

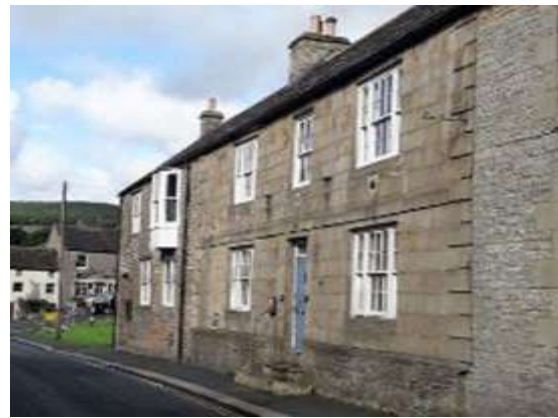
Figure 57 Former Bluebell Inn (Grade II Listed)

- 4.3.4 Beyond Alston Hotel are two consecutive rows of 18th century terraces on either side of the road; the one on the east with the Bluebell Inn is much smaller than the one on the west, which continues down the Station Road hill.
- 4.3.5 The eastern terrace row, which is all Grade II Listed and includes the Bluebell Inn to its northern end, has a uniform two-storey height and Georgian

character with wide frontages in coursed or ashlar stone, quoins and regular opening pattern with timber multi-pane sashes and panelled doors. Two out of three buildings are currently vacant, with a prevalence of cementitious pointing and render, as well as decayed timber frames.

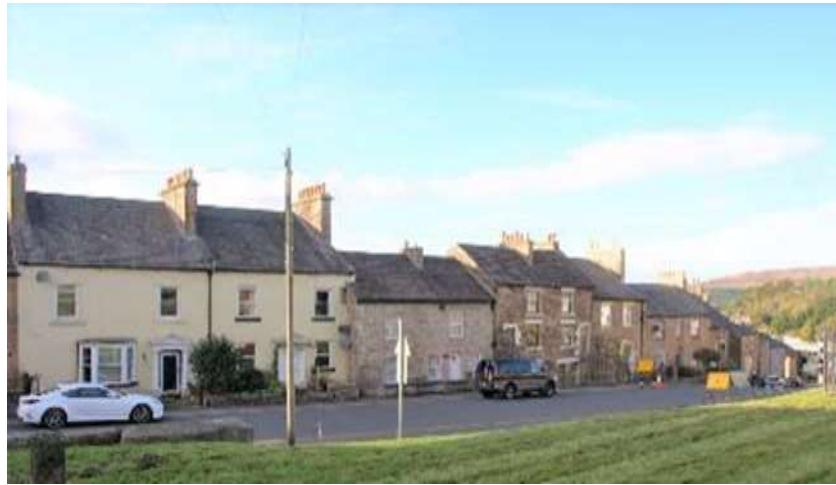
Figure 62 Western terrace row

- 4.3.7 Further, down Townfoot, the western terrace row has a more piecemeal character than the eastern row with no uniform building line. Many of the

buildings were reconstructed in pairs. They are two- to three-storeys high, sometimes with half-basement level, with access to rear gardens and stone steps to entrances to accommodate the land's incline. There are several examples of overbuilding onto the gable end of the house, eg Sun House.

- 4.3.8 The buildings display late 18th-early 19th century characteristics – stone rubble or coursed walls, shallow pitched stone or slate roofs, regular openings with large stone surrounds or lintels and sills, timber sash windows and panelled or plank style doors, as well as small front gardens with low stonewalls, sometimes complemented with railings. With the exception of no.1 and no.2 Townfoot, the first half of the row is Grade II listed. No.3 and no.4 Townfoot are notable for their incised stucco finish and pediments above doorways. The listed buildings are in moderate to good condition, with some cement re-pointing and one property with uPVC windows. The unlisted buildings of the second half of the row have however been more altered with a majority of cement mortars and uPVC windows, and suffering lack of maintenance. Grey satellites dishes are also detracting from the traditional character of the whole row.

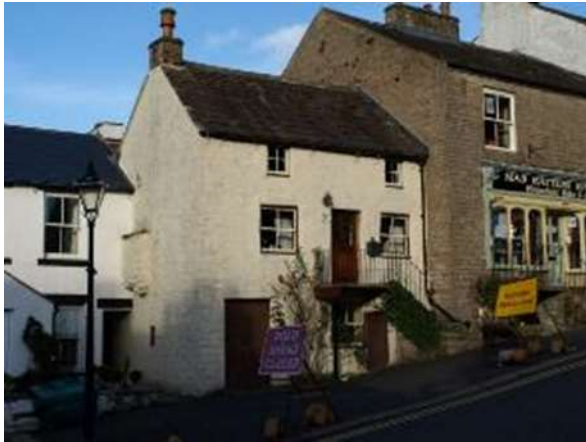
periods. Grade II Listed Cobbles End Cottage provides evidence of first floor living arrangement with an oven projecting at first floor level, denoting the position of the kitchen. Former Kings Arms (TLC Hair Design) is also noted for its rare ashlar work with moulded surrounds.

Figure 68 Grade II Listed Cobbles End Cottage with projecting oven to the left

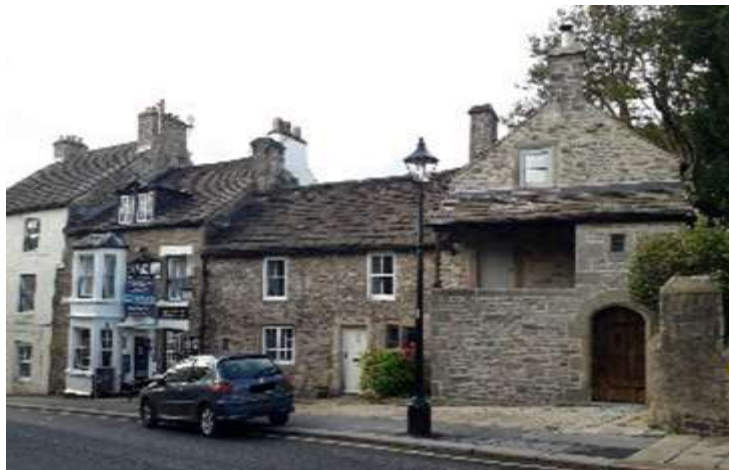
Figure 70 Row of 17th century buildings (Grade II Listed)

4.3.15 The road widens around the entrance to the Church due to the demolition of former properties at the corner of the church gates. Grade II Listed Kings Arms Building, Angel Inn and Church Gates form a small frontage of 17th century origins, with the former and latter displaying date stones. The Church is set back from the street, surrounded by its churchyard.

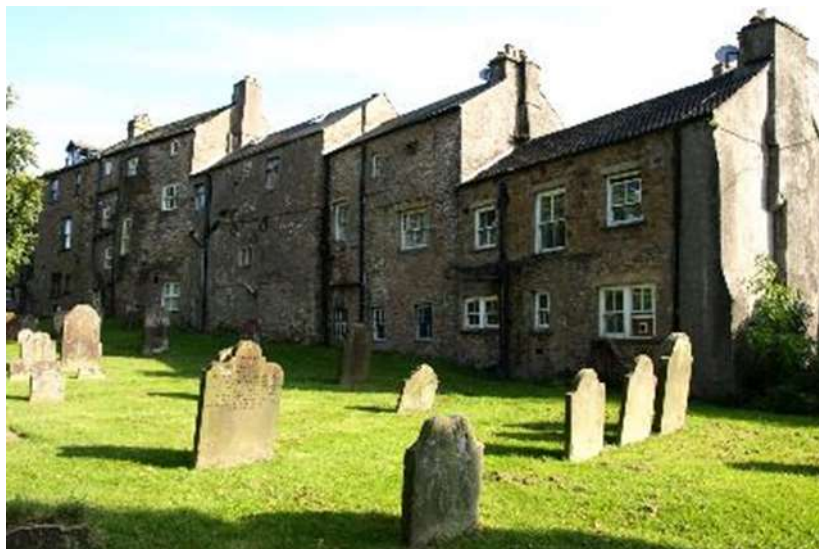
Figure 73 Rear elevation of 17th century buildings bounding the churchyard

4.3.17 Within St Augustine's churchyard, 17th century random rubble masonry can still be seen on the rear elevation of the Grade II Listed Front Street buildings. These single-pile buildings display a wealth of historic openings from chamfered windows to later sashes, as well as evidence of central stairwell layouts. The churchyard of medieval origins forms an attractive green space with mature trees and historic headstones, however now mostly illegible. The Grade II Listed Victorian Church, with its spire dominating the town's skyline, is in moderate condition with evidence of stone decay potentially due to water ingress and cement pointing.

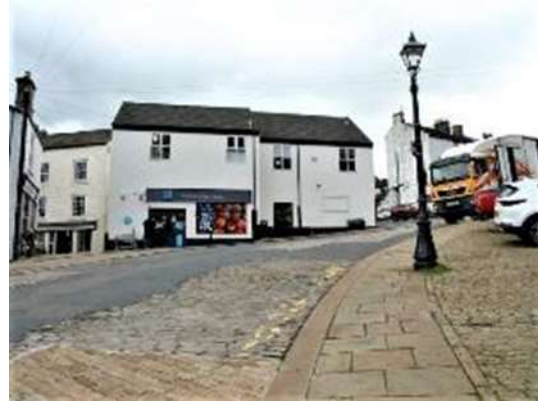
Figure 78 Co-op

representative of 20th century building in this area and its low architectural quality is unsympathetic to the area. Its car park to the south adjoining the Potato Market provides open views on the stone buildings of High Mill former industrial complex currently in poor condition. Woodland, green fields and a modern estate beyond enclose the view.

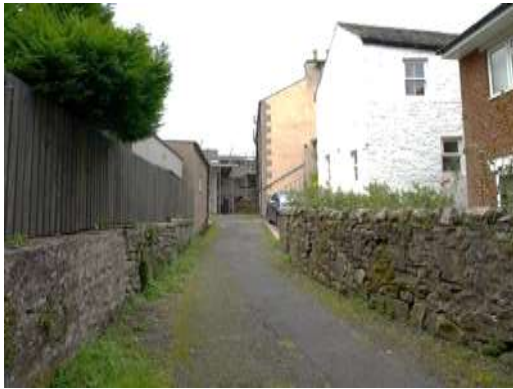
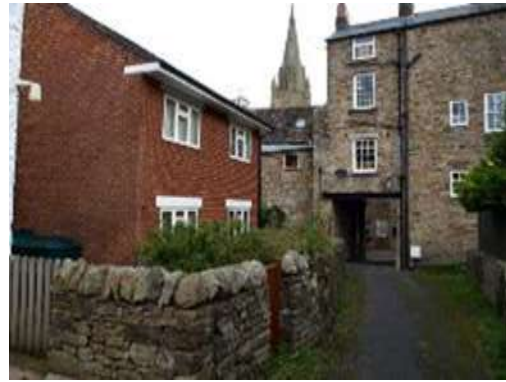
4.3.22 On the southern side, Grisedale Lane accessed underneath Arch House has an open aspect following the demolition of some buildings for the construction of Grisedale Croft care home in late 20th century. It has lost most of its cobbled path to tarmac, and the traditional character of the stone buildings and boundary walls contrasts with the modern Church Road houses. There are a number of low quality garden sheds and garages.

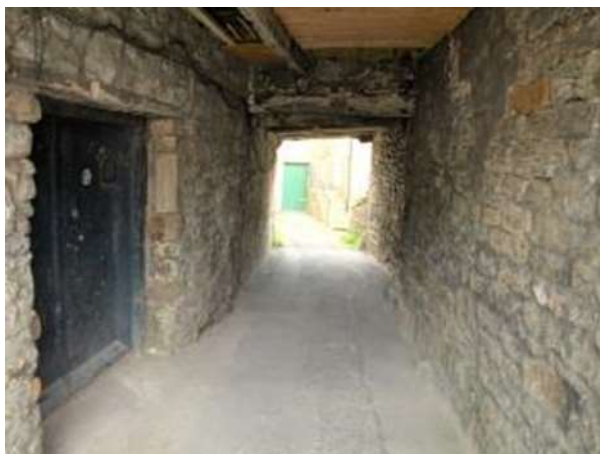
Figure 83 Stone archway to Kate's Lane

4.3.24 Kate's Lane is accessed through a stone arch of The Old Clock Shop, in need of structural repairs, and gives on to a variety of much altered stone rubble buildings of both domestic and industrial character, many with uPVC windows and doors. They form a small courtyard, which retained its cobbled setts. Cottongrass Cottage and The Old Cottage have first floor entrances with external stone steps. The latter also has a 1621 date stone, but refers to the 1000-year lease of Alston Moor for large agricultural tenements, or land holdings, later subdivided into small parts for building plots. These cottages were however in existence on the 1775 map. A 19th century warehouse with corrugated roof lies vacant with boarded openings.

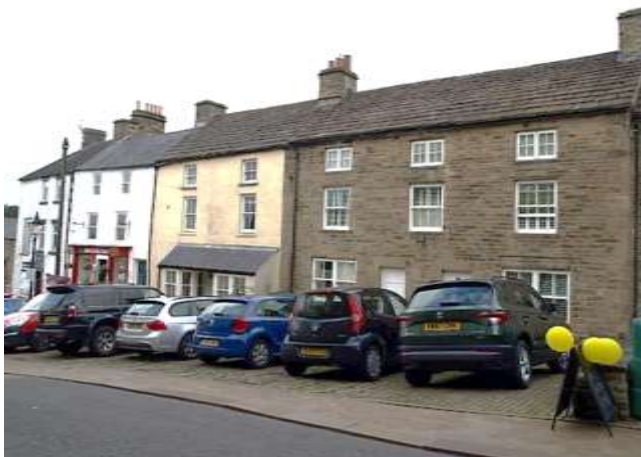
Figure 85 Eastern row of buildings

4.3.26 This area is used for car parking, which reduces the character and sense of the historic public space. The eastern boundary of the space is lined by residential and commercial buildings of uniform height, but mostly irregular opening patterns. The first half of the row has render whilst the second half has facing stone. The Post Office is notable for its well-maintained traditional shopfront in front of a flagged terrace and stone steps. The Crown Hotel on the corner has currently a poor appearance with deteriorating paint and has a blind bay due to the demolition of adjoining buildings. The few modern alterations on the row are UPVC frames on several properties, as well as the canopy and seating area on a raised flagstone platform on the gable end of Hatters House. The later marks the southern boundary of the market area.

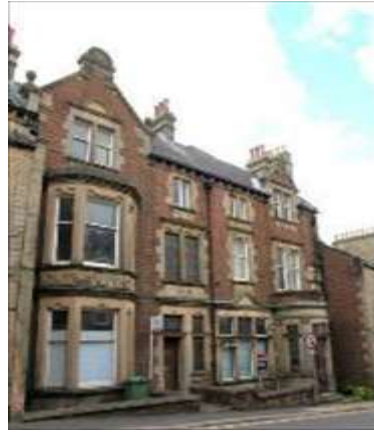
Figure 90 Former Barclays Bank

4.3.29 Going south beyond the Potato Market, the former Barclays Bank on the eastern side is set back from the building line and stands out for its highly decorated façade. Yet it is currently vacant and in a poor state of repair. The majority of buildings on this part of the street are also generally in poor condition with cementitious mortars and renders and have been altered with modern window designs. No 2 and No 3 West View have however well restored shopfronts.

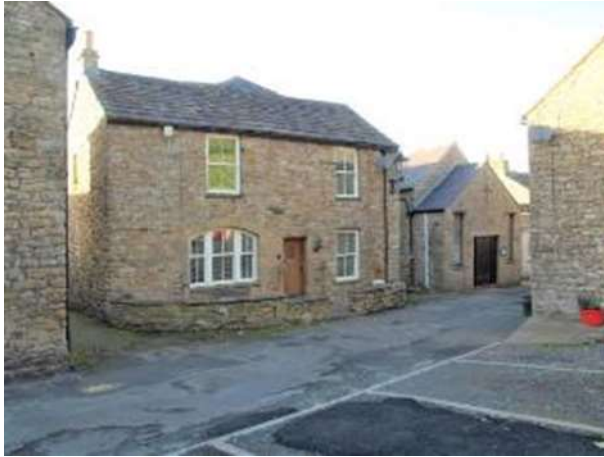
Figure 93 Masonic Hall (left) and St Wulstan's (right)

- 4.3.32 There are two ecclesiastical buildings in the area: the Masonic Hall and House, and St Wulstan's – a rubble built structure of late 18th century which has several blocked doorways and windows, which may explain its possible former use as a gaol, prior to its conversion to a church in 1950. A cobbled alleyway survives on the left-hand side of the church.

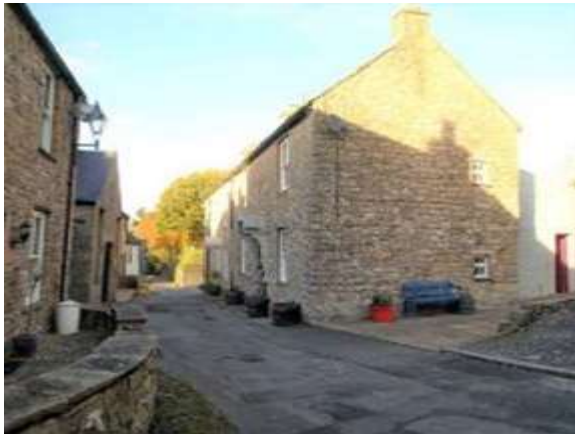
Figure 95 Traditional cottages on Kings Arms Lane

4.3.33 Further north are 18th century traditional cottages built on either side. On the left-hand side, Hamilton House displays a pair of blocked doorways indicating first floor entrances. This eastern row of terraces have been altered with 19th century openings and well-designed 1920s concrete canopies over doors.

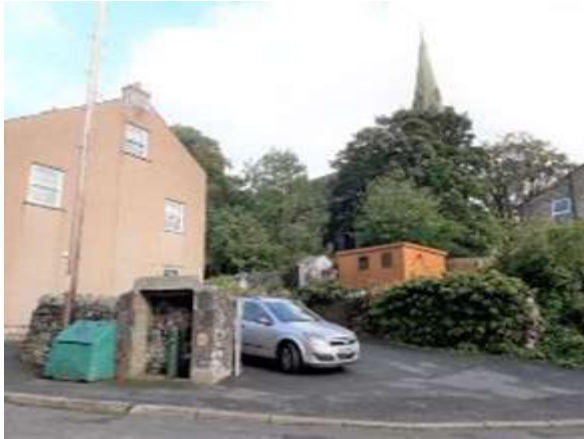
Figure 97 Surviving standpipe in wall section

4.3.35 Here the lane is bounded by high rubble stonewalls which form a characteristic of the area. One of these walls was however lost to a 20th century terraced development on the west side of the road, leaving only a section enclosing one of the town's cast iron standpipes. Together with older adjoining terraces, this row have a modern appearance with cement render, uPVC frames and glazed uPVC front porch additions, of low architectural interest.

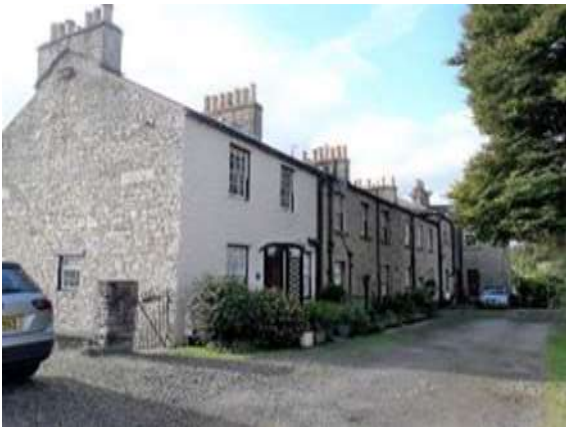
Figure 99 Croft Terrace

4.3.36 On the east side of the road, Croft Terrace laid along a private lane is an excellent example of mid-19th century terraced housing and is in good condition with historic 6x6 sashes surviving on most houses. Opposite is Hollytree Lodge, a substantial late 19th century villa of Tudor gothic styling, a rare example of its kind in Alston. However, it now has uPVC frames. The 20th century The Bungalow immediately to the south is of low architectural merit and of much smaller scale than the surrounding buildings.

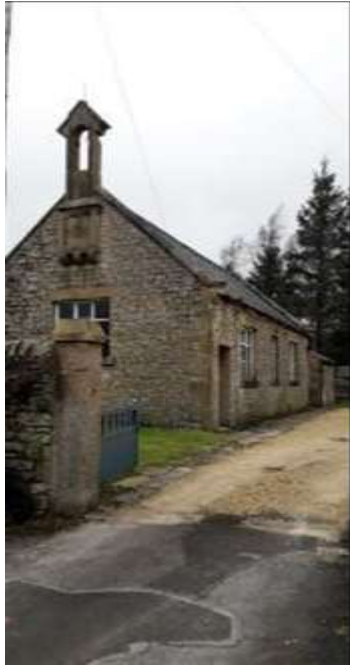
Figure 101 Former Salvin School's buildings

4.3.37 The former Salvin school buildings further up the lane form an informal courtyard layout, built in rubble with sandstone dressings and kneelers, and the School Hall notable for its gable end bell cote. They all have been converted into dwellings without too many alterations, although the Old School House has now uPVC frames and uncharacteristic timber fencing.

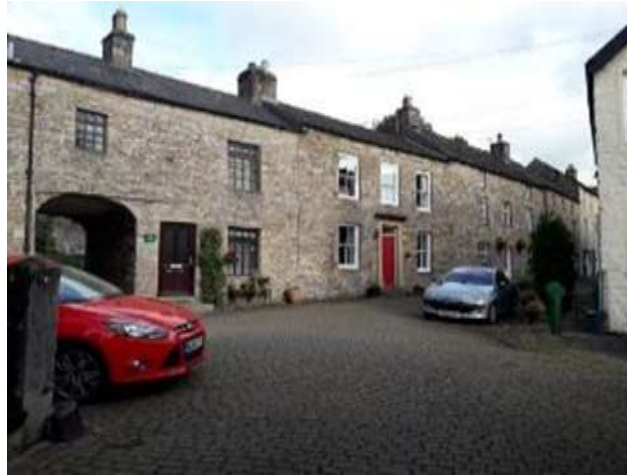
Figure 103 Coach entrance and paved lane

4.3.40 There is a good deal of evidence to suggest this was once a busy multi-functional part of the town centre with houses having former first floor domestic entrances and ground floors for agricultural or industrial purposes eg Blacksmith's Cottage. Arched coach entrances are also observed at Butt Mews cottages and Carriage Cottage. There is also a culverted beck running under the area, which was exploited, by mills.

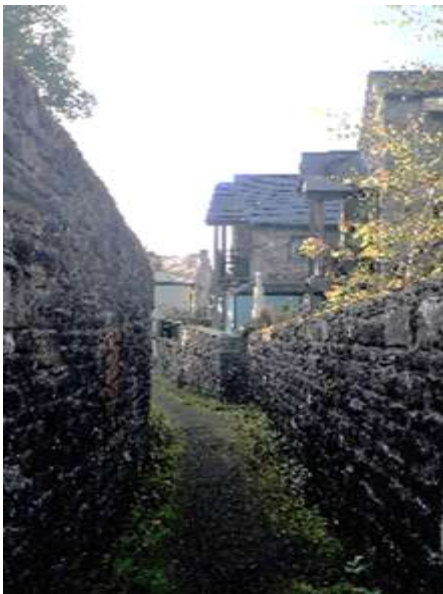
Figure 105 Renovated cottages with modern covered balconies

survival of traditional timber windows and doors on the main alley, many replaced by uPVC windows and poor casement designs. There is better survival along secondary alleyways and around the informal square facing Back Garth. Church View Cottage has a rare 17th century chamfered leaded window. Church View's door case has plain stone pilasters and moulded cornice, an unusual design for the area. Stokoe House has attractive plank barn door shutters. A few modern porch and balconies additions are also noted. Overall buildings appear in sound condition.

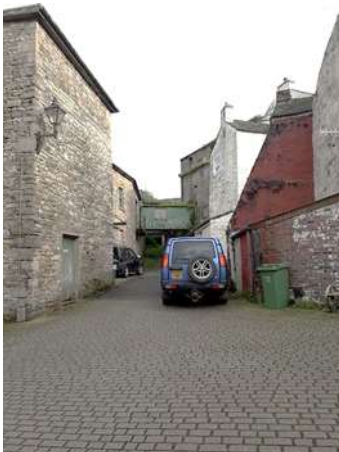
Figure 109 High Mill (Grade II* Listed) industrial complex

4.3.44 In an area directly to the east of the Market Cross is the High Mill complex, comprising Grade II* Listed High Mill, the 18th century water-powered mill, adjoining High Mill House, and two large 19th and 20th century factory blocks developed for modern engineering industrial use, linked to High Mill by covered aerial walkways. The mill and factory buildings have created a distinctive landscape of tall, three or four storey buildings, giving a utilitarian and industrial character to the area. This sense of self-contained industrial area contrasts sharply with the commercial and civic character of the nearby Market Place. However, the High Mill complex is vacant, partly derelict, many openings boarded up, and invaded by vegetation, which harms its significance and is detrimental to the character of this area in close proximity to the town's main street.

4.5.3 Of prime concern is the dereliction of the large High Mill complex, including a Grade II* Listed Building, affecting half of a character area and adjacent to the main street. Other listed buildings remain vacant and/or in poor or moderate condition at the time of appraisal, including the Bluebell Inn, Salvin Cottage and the former Barclays Bank and adjoining Oscars House. There are also non-designated heritage assets considered at risk: the former Tyne Café and the Wesleyan Methodist Chapel.

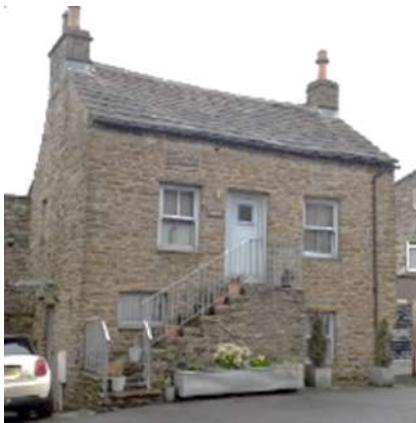
Figure 111 Jaycot

4.3.46 The 'house-over-byre' form of housing is most prevalent in Back o'the Burn where examples such as Jaycot may date from the late 19th century, underlining the continuing importance of this building tradition well into the modern period. The three-storey Old Forge or Smithy, converted to dwelling, retains its former industrial character with elongated workshop windows, and encloses the street to the south at the junction with Townhead.

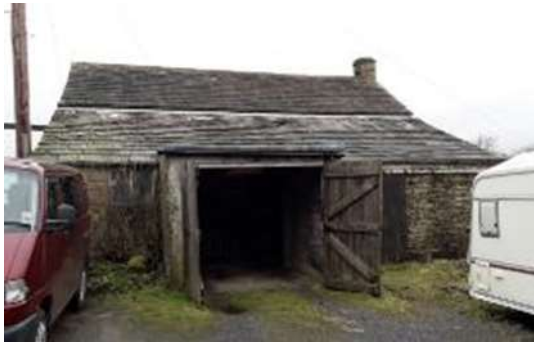
Figure 115 Outbuilding with surviving stone roof

4.3.48 Many of the outbuildings/annexes have been altered with metal roofs, up-and-over garage doors and/or cement rendered walls. Front yards are either grassed over or paved with sandstone cobbles or flags, but some replaced by concrete flags, gravel or tarmac.

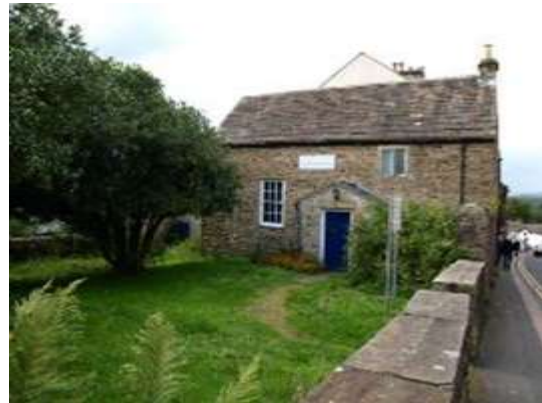
Figure 122 Quaker Meeting House (Grade II Listed)

4.3.53 The 18th century Quaker Meeting House and its walled burial ground on the southern part of Front Street opens up the view and the ground is a quality green space with mature trees. The garden walls have however lost their railings. The Grade II Listed building, which is one of the earliest buildings in the town, is well preserved. It faces uphill rather than onto the street and its side elevation goes over building line, forming a clear separation with the more densely built town centre.

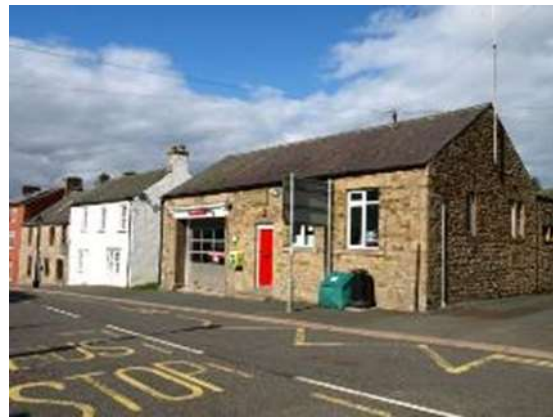
Figure 126 Fire Station (former Grammar School)

4.3.55 In the area surrounding Victoria Square, buildings are of various sizes, layout and appearance. On the east side, buildings are arranged in informal terraces, with the detached fire station in between. The first row continuous with Front Street dates from the 18th century and shares the same building line. All buildings are rendered, with the exception of Mill Race House. The character of these buildings have been much eroded with uPVC or modern designs of frames, widened openings, cement render or pointing. The former Grammar School has been creatively converted into a fire station. A date stone indicates it was rebuilt in 1828 and the phased alterations to its openings are evident.

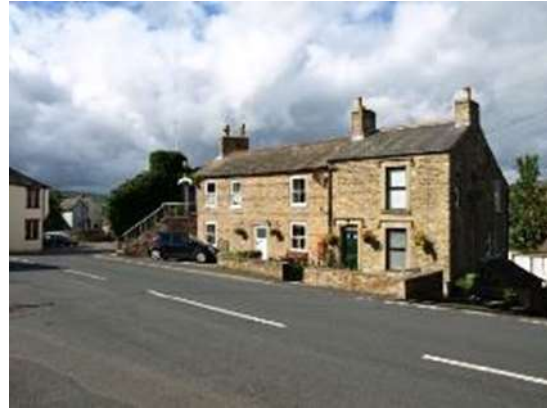
Figure 128 Amble Cottage and Westoe House

4.3.56 The second row following the fire station comprises a pair of tall semis adjoined by a smaller row of cottages and dates from the early 19th century. The cottages follow the sharp curve of the road and on to Nenthead Road. The buildings are either stone facing or rendered, most with cementitious mortars. The first half of buildings on Townhead have modern window frames. The second half is better preserved, with the Amble Cottage notable for its retained separate first floor accommodation accessed by external stone steps, and unusual decorative stringcourses in iron rich stone. Adjoining Westoe House also has rare hood moulds and full stone window surrounds.

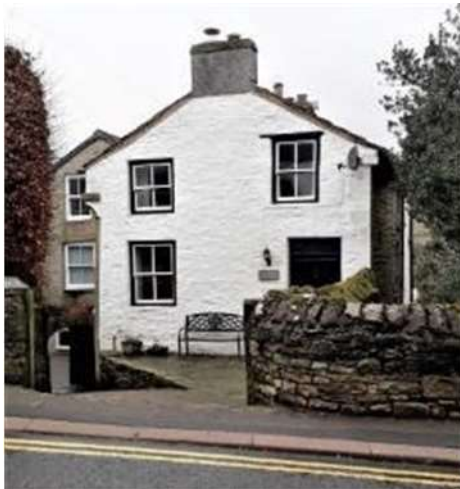
Figure 129 No 1 The Hundy (back) and Hundy Cottage (front)

4.3.57 On the west side of Townhead between the Quakers Meeting House and Victoria Square, is a cluster of buildings set well back from the street, all of very different designs. Early 19th century Hundy Cottage and No 1 The Hundy just visible to the rear are characterful traditional stone rubble houses, albeit altered with modern window frames. Adjacent properties No 2 The Hundy and Dorville have had significant alterations eroding their historic character and interest.

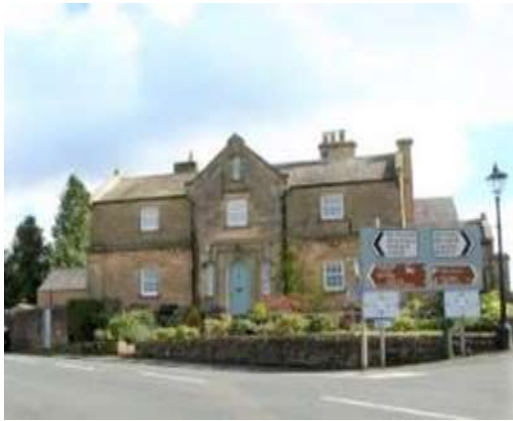
Figure 131 The former Police Station

4.3.58 Up the hill past Victoria Square, the road forks at the former turnpike into Garrigill road to the south and Nenthead road to the east, creating another civic space. The former mid-19th century Police Station sits prominently in this space. This building retains most of its elaborate architectural features and landscaped garden to front, an unusual style for Alston and reflecting the importance of the institution in the town. Its original timber sash windows have however been replaced with uPVC. The low stone garden walls have also lost their railings.

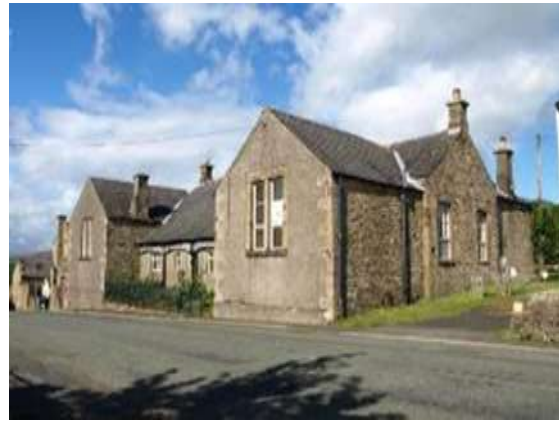
Figure 132 Former free school

4.3.59 To the rear of the Police Station is the Topp Community Centre, a former 19th century Free School. It has pebbledash cement render on its gable ends, decaying timber frames and modern blue round top railings. It remains a well-designed Victorian building, which forms the southern boundary of the conservation area. Beyond the boundary, adjacent and opposite rows of 19th and 20th century terraces have been significantly altered, and together with an out-of-scale bungalow, form a contrasting setting to the quality of the conservation area.

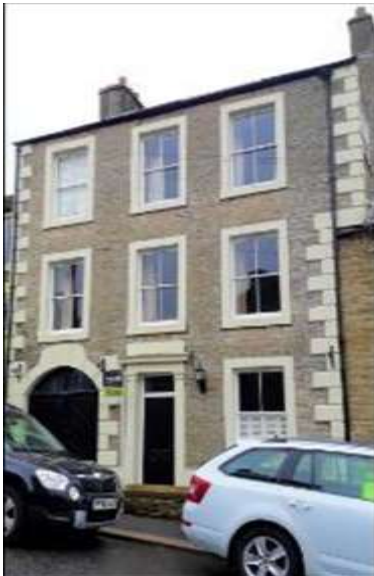
Figure 135 Albert House

4.3.60 To the west of the Police Station on Townhead is a long terrace row with varying massing and storey heights. They are generally well built with stone detailing. There is however low survival of traditional timber sash windows and doors. The tallest terrace in the row, Albert House, is considered of architectural interest with protruding stone surrounds to all openings, including an arched garage doorway with voussoirs, with a timber coach entrance plank door. Aldentstone is also notable to a lesser extent for the quality of stone detailing, traditional windows and doors and stucco finish of its front elevation. Adjoining Steel House is in poor condition with peeling paint, which detracts from the appearance of the row. There are small roof lights on both houses as

well as on Albert House breaking the continuity of the roofscape of the row, comprising a mix of stone flags and slates. Most of the row have small walled front gardens of varying quality.

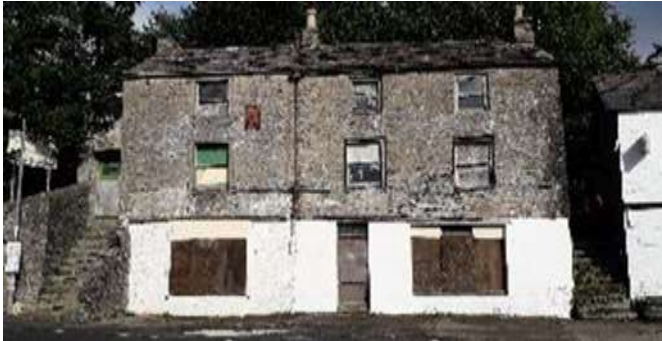
Houses with former byre below, altered to a shopfront, C18. Two semi-detached properties with rectangular plan form, 1-bay and 2 bays, 3 storeys. Sandstone slate roof with gable stone chimneys, rough faced masonry, formerly painted, dressed and tooled quoins to left hand corner only.	Architectural and age interest: well preserved C18 or earlier bastle house example, with rare side external stairs arrangement and typical adaptation of ground floor byres to shops.	Poor: derelict, vacant and boarded up, on Buildings At Risk SAVE Register, tie rod for structural integrity, decaying window frames, missing rainwater goods sections. Danger of collapse.

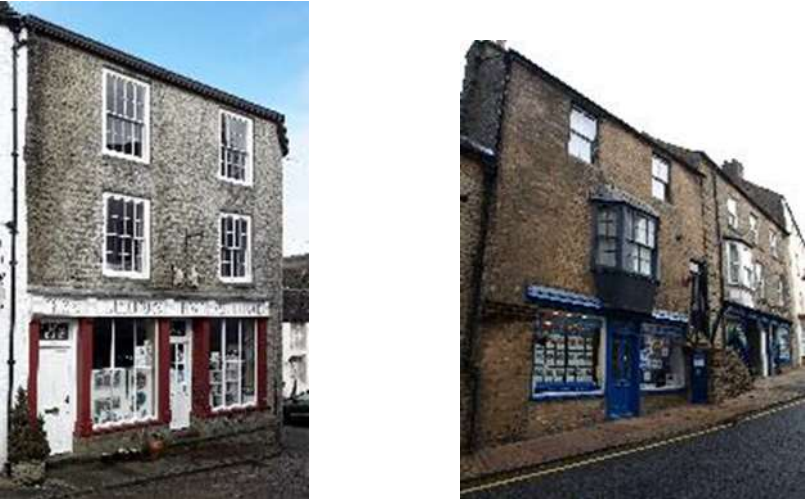
<p>Shops with accommodation above, late C17 or early C18 with C19 alterations. Single-piled plan.</p> <p>Studio House: end terrace, L-shaped plan to rear and large chamfer to corner, 3 storeys, 3 bays.</p>	<p>Group value, architectural and historic interest: part of a 17th century terrace row housing the first series of shops of the town facing the market. The rest of the row is Grade II Listed due to the quality of the front elevations re-fronted in the 19th century.</p>	<p>Moderate with cement pointing or render causing mild stone decay, some rainwater leaks to Studio House.</p>
