Alston Conservation Area Character Appraisal and Management Plan

March 2023

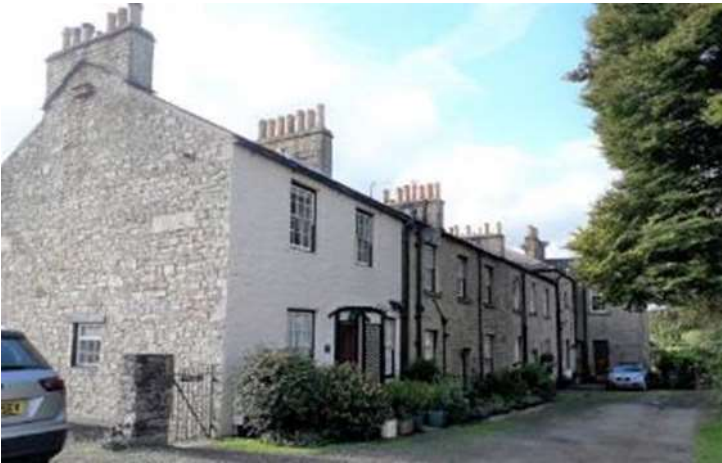
Property	Description	Local interest	Condition
Croft Terrace, nos. 1, 2, 3 (also called The Founds), 4 and 5

<p>Cottages, phased building 1841-1861. Terraced, 2 storeys with basements. Welsh slate roofs with ashlar stone chimneys above left party walls, snecked rubble stonewalls, as well as rusticated door surrounds, stone sills, lintels, and quoins except at No 1. Stone planter area to front of Nos 1 and 2.</p>	<p>Historic and architectural interests: a rare example in Alston of an exclusively mid-century residential development. It was built on land called Church Croft on the 1775 map and was initially called Church Terrace on the first OS map of 1861.</p>	<p>Good.</p>

Property	Description	Local interest	Condition
	<p>Number 1: earlier or later build, painted front elevation. Central panelled door with 1 window on both sides and two above, all 6x6 sashes with horns. 3 windows with stone heads to side, 2 blocked.</p> <p>Numbers 2 and 3: same build period. 3-bayed with central door with 1 window on both sides and 3 above, all 6x6 sashes with exception of one 8x8 window at No 2. No 2 door panelled and No 3 partially glazed.</p>	<p>The lintels on the south gable show that the row was intended to be continued. Modern frames of No 4 and 5 however harm the row's character.</p>

Property	Description	Local interest	Condition
	<p>Numbers 4 and 5: later build with increased height and hipped roofs, and No 5 forward from building line. No 4 has central panelled door with one window to left, tall half-floor window possibly indicating former external upper floor access, and 2 first floor window. Modern UPVC casements and 1 small timber sash. Basement light well between Nos 4 and 5. No 5 has half-glazed door to side return with tall UPVC multi-pane casement above and secondary door to front.</p>

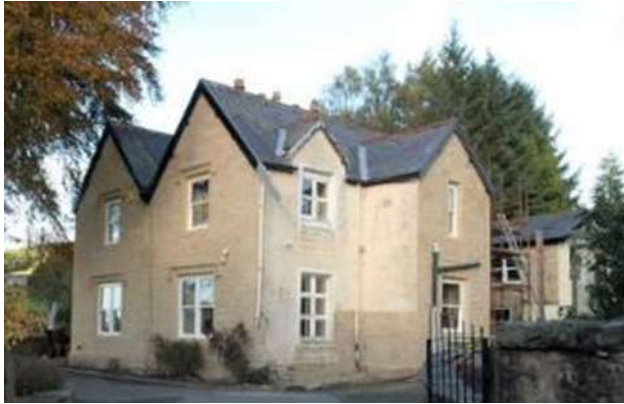
Property	Description	Local interest	Condition
Hollytree Lodge

<p>House, C19. Detached, double-pile plan with central gabled wings and smaller two-storey wing linked by bridge. Slate roofs, central stone chimney, stone ashlar walls with quoins and plain surrounds, hood moulds to several windows, all 1x1 uPVC sashes,</p>	<p>Good.</p>
		<p>Historic and architectural interests: rare example in Alston of 19th century detached house, large villa with Tudor gothic styling and suitable for professional occupation, may have had housed the Salvin School's headmaster and/or a doctor and his surgery.</p>

Property	Description	Local interest	Condition
	slate hipped canopy on stone brackets over entrance door. Bridge timber framed and plastered walls.	In a national context, it may be considered relatively unremarkable in its form and style but it is notable in Alston due to the scarcity of this particular building type in the town. Modern frames however harm the building's character.

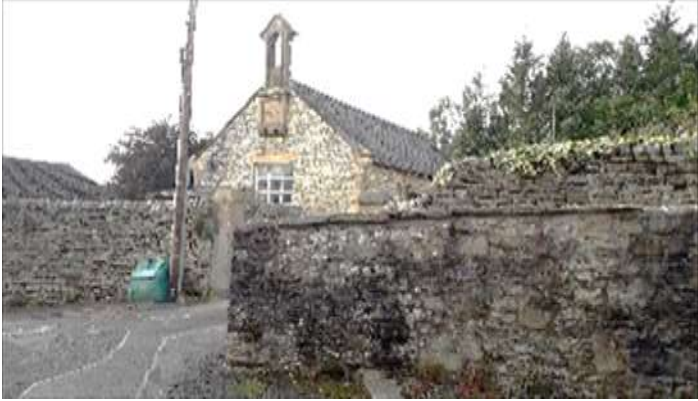
<p>Former school buildings and boundary walls contained within a courtyard, 1844-1851. Detached.</p> <p>Salvin Schoolhouse: vacant, 4-bays single storey with tall slender bell cote with bell missing, porch way to north end with adjoining 1880s two-bay service block.</p>	<p>Historic and architectural interests: a major legacy of school building during the 19th century in Alston Moor sponsored and managed by Hugh Salvin, an influential vicar of the parish. The first of these school buildings, for girls only, was constructed under the terms of the scheme promoted by the National Society for Promoting Religious Education,</p>	<p>Good for Girls National School and Schoolhouse, but moderate for vacant Salvin Schoolhouse with decaying frames, open joints in stonework, bell cote with iron strappings causing erosion and cracking of stonework, and roofs of adjoining buildings in poor condition.</p>

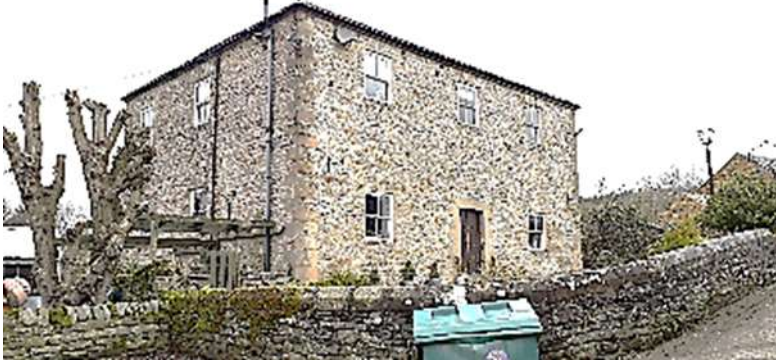
Property	Description	Local interest	Condition
Former Gossipgate Chapel

Former Congregational or Independent chapel, house, 1804. Detached, rectangular plan with symmetrical openings, two-storey, 3 bays, hipped traditional slate roof, coursed regular stone rubble with quoins. Rusticated surround to central entrance, double timber plank door.	Historic and architectural interest: only congregational chapel of Alston demonstrates the variety of denominations in this remote town. Polite architecture, more akin to domestic buildings of the Georgian period than a chapel. Modern frames however harm the buildings' character.	Good.

Property	Description	Local interest	Condition
	Undressed slim lintels and sills to windows with 2x2 UPVC sashes. Walled garden with curved rubble stonewall and chamfered copings, central front cast iron gate and slender posts, arched head and round sign above, side boundary walls with saddle stone copings.

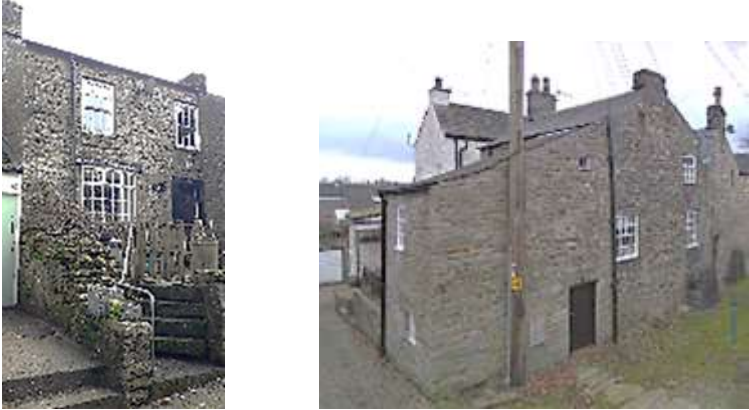
Property	Description	Local interest	Condition
Church View Cottage

House, circa 1690, with later addition to south-west corner. L-shaped plan, terraced, elevated on the western elevation with retaining wall to patio area, 2 storeys on west, and 3 storeys to south. Welsh slate roof with flush stone chimneys to gable ends, rubble stonewall, formerly painted.	Historic and age interest: the earliest known building in the Butts area with date stone, indicating the extent of development of the town in the 17th century. Georgian frontage and rare original chamfered and leaded window to the side elevation of architectural interest.	Good. Cement pointing noted.

Property	Description	Local interest	Condition
	<p>Bay window, undressed slim lintels and sills to windows. Monolithic stone door surround, with eroded date stone '169(?)'. Blocked second door to left, modern widened oriel window to left with multi-pane timber casement. Above, 6x6 timber sashes with horns. South-west extension in coursed stone also formerly painted. On gable end, moulded stone lintel to ground floor window, blocked up window and small square opening to side elevation.</p>

Property	Description	Local interest	Condition
	First floor windows modern multi-pane timber casements and C17 small diamond quarry leaded window panel within chamfered stone surrounds to attic.

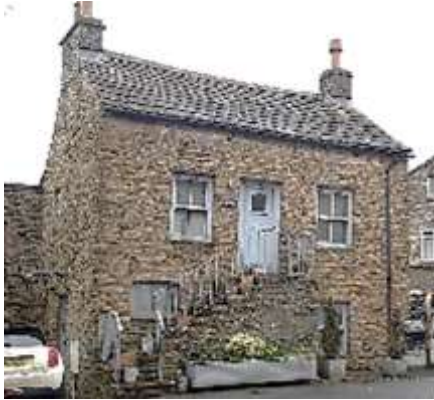
Property	Description	Local interest	Condition
Jaycot

<p>House, mid to end C19. Detached, rectangular plan with cat slide roof extension to rear. Two-storey, three bays. Stone flagged roof with gable end chimneys, stone rubble walls with chamfered section to base of south-west corner. External stone steps with modern metal balustrade to first floor central entrance.</p>	<p>Architectural interest: a well-preserved and distinctive 19th century cottage, late example of the bastle-house type. Modern frames and adjacent modern garages however harm its character.</p>	<p>Good.</p>

Property	Description	Local interest	Condition
	Undressed stone lintels and sills, to front 2x2 UPVC sashes and two blocked windows to attic, to side one secondary entrance and casement windows. Two garages to south side with corrugated cement sheet roof.

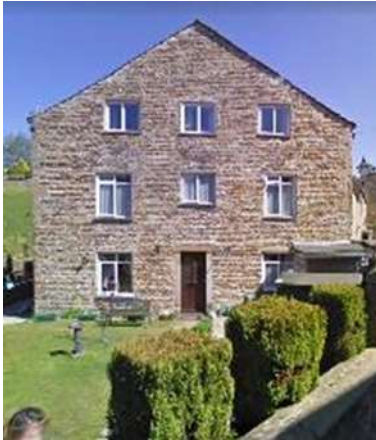
Property	Description	Local interest	Condition
Holme Lea and Chapel House (former Methodist Chapel)

Former Wesleyan Methodist Chapel, 1797, enlarged in 1825 and converted to residential in 1867-8, now two dwellings. Detached, large rectangular plan, three storeys with ground floor set lower than street level, 3-bays on original gable end front elevation, set at a right angle from the street,	Historic interest: Alston's first Wesleyan Methodist Chapel and the sole representative from the early period of the movement's implementation in Alston Moor. It represents the early popularity of non-conformism in the area. It was made redundant when the Wesleyan Methodist Church was built in Townhead.	Good.

Property	Description	Local interest	Condition
	<p>back from garden area. The roof has modern smooth concrete interlocking tiles with central and east gable end chimneys, rubble stonewalls with quoins. Symmetrical opening arrangement to original front elevation, with central entrance partially glazed door with monolithic stone surrounds, two windows on each side and three on each upper floor with modern casements. Side elevation facing the street has ground floor openings accessed by stone steps down, with low boundary walls to left hand-side.</p>	<p>Whilst Methodist chapels tend to have minimal architectural ornament onto what is usually a 'rectangular box' building, the building's imposing massing and gabled front elevation oriented away from the street gives clues of its former function. Its early conversion to housing demonstrates also the adaptability of the building when its original use became redundant. The concrete tiled roof and modern frames however harm its character.</p>

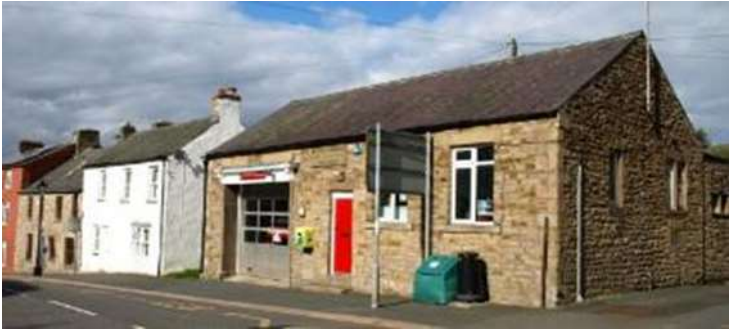
Property	Description	Local interest	Condition
Fire Station (Former Grammar School)

<p>Grammar School, now fire station, 1828. Detached, rectangular plan, single storey. Slate dual-pitched roof and coursed rubble stone with quoins and rusticated door surround to large front entrance, now partly blocked with narrower single timber plank door.</p> <p>Historic interest and architectural interest: Alston Grammar School was amongst the first institutions to benefit from the trend towards renewed education provision in the parish; it was re-built by public subscription in 1828, a straightforward but high-quality structure that proved to be highly adaptable as currently used as the town's fire station.</p>	Good.

Property	Description	Local interest	Condition
	<p>Date and name stone over doorway, dressed lintels and sills, two uPVC multi-pane casements and one large shopfront with former windows' heads above. Timber fascia, cornice, corbels, and concrete jambs with recessed modern roller blind. Shopfront now converted into garage entrance for fire station vehicles. Large defibrillator yellow box to side of pedestrian entrance. UPVC casements to side elevations and modern float roof extension to rear.</p>	<p>It was partially endowed by Greenwich Hospital. Despite significant alterations to its former symmetrical opening arrangement on the front elevation, the phases of development are fully visible from original school function to later shop and finally fire station. The later change of use has been carried out relatively sensitively with only a discreet sign on the fascia and modern roller blind. Modern frames however harm the building's character.</p>

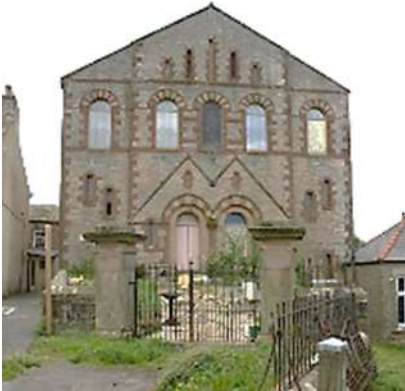
Methodist church, now vacant, 1867-68. Detached, rectangular plan with small extension to rear under the same roof, tall five-bay façade with three levels of openings. Set at an angle from the road, facing north. Dual-pitched slate roof with sandstone copings and one gable end chimney surviving.	Historic and architectural interest: designed by R.F.N. Haswell, specialised in designing Methodist churches, it is exceptionally decorated for the denomination and the area.	Poor: vacant, some openings boarded up, signs of damp and stone decay.

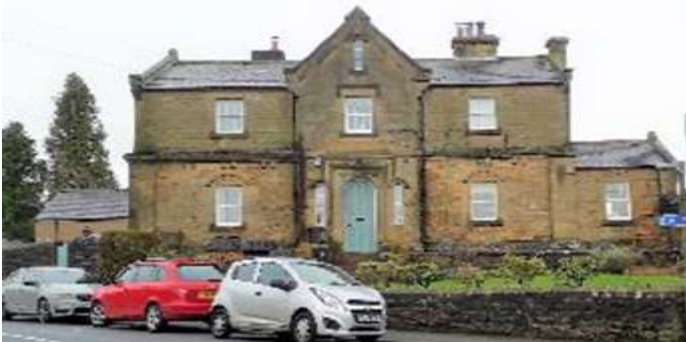
Property	Description	Local interest	Condition
Former Old Police Station

Police Station, now house, 1850. Detached building sat in a triangular site at the junction between the roads to Garrigill and Nenthead, facing north. Rectangular plan with cross-gabled roof and single storey side extensions.	Historic and architectural interests: the Police Station was created because of the appointment of Parish Constables by Act of Parliament 1843, with the influential Reverend Salvin as one of the petitioners for the building. It was initially named The Lock-up House as it was designed to house three lock-up cells and accommodation for the keeper.	Good.

Property	Description	Local interest	Condition
	<p>Slate roof with stone parapet and kneelers to gable ends and stone ashlar chimneys on ridge and one external stack to south-western side elevation. Stone ashlar walls, with stringcourse, hood moulds and rusticated window surrounds and carved jambs to timber plank front door with cover fillets and nails. Central gable capped with heavy stone parapet and copings, and pilasters to corners up to level of stringcourse. Three round headed tall lancet windows to front elevation. All window frames uPVC, multi-pane sashes or casements.</p>	<p>No architect has been identified but the builders were William Armstrong and Sons. The building is firmly of 19th century style and commands a key site at the junction of the Nenthead and Garigill roads, giving it an imposing presence. Well-proportioned grand and imposing frontage, as well as heavy gabled elevations to sides as well as rear, all illustrating strength and imposing physical attributes of the police station. It is also noted in Pevsner's Architectural Guides. Modern frames however harm the building's character.</p>

Property	Description	Local interest	Condition
	Triangular garden to front with retaining wall to road, formerly with railings, and second retaining wall up to ground floor level with steps up to main front door. All garden walls snecked rubble with saddleback copingstones.

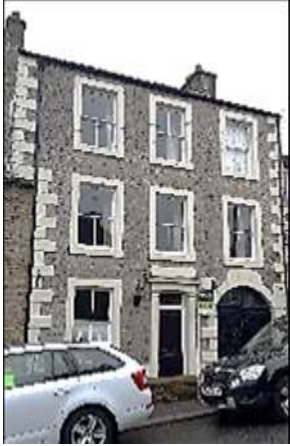
House, mid C19. Terraced, rectangular plan, 3 storeys, 3 bays, regular proportions. Welsh slate roof, stone chimneys to each gable. Irregular coursed stone, with painted protruding chamfer edged quoins and surrounds.	Architectural interest: noted in Pevsner's Architectural Guides, it is a rare example of a grand, purpose-built house for wealthier members of society in mid-19th century Alston.	Moderate. Cement pointing causing mild stone decay.

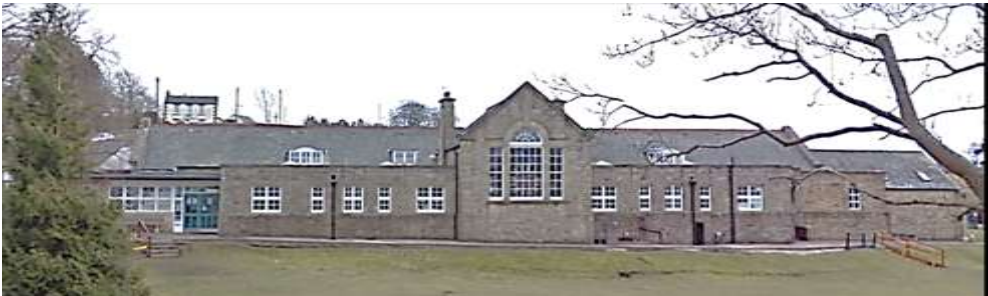
Property	Description	Local interest	Condition
Former Alston Primary School (first known as Samuel King Secondary School)

<p>Former secondary then primary school, now vacant, 1909. Detached, complex cross-gable linear plan with set of wings and later side and rear extensions, single storey with attic space, 10 bays. Welsh slate dual-pitched roof to cross-gable central parts with decorative ridge clay tiles and tall tapered stone chimneys, flat roof with stone parapet to front wings,</p>	<p>Architectural and historic interest: the school was part of the first generation of schools created under the 1902 (Balfour) Education Act, funded from local taxation under the direction of the Local Education Authority. English Heritage (2010) noted,</p>	<p>Good.</p>

Property	Description	Local interest	Condition
	GRP to side/front extension to right, concrete tiles to rear extension. Rusticated sandstone ashlar to walls with mid-height plinth, as well as flush quoins and surrounds. Modern main entrance flat roof porch to far right, secondary entrance to far left under stone hood up stone stairs. Modern front door has glazed panels and modern porch windows are multi-pane casements reflecting but not quite reproducing the historic windows on the rest of the front elevation.	“the new school centralised educational provision in the town and was indicative of a developing role for public investment and welfare provision, creating the largest and perhaps the most accomplished architectural monument in Alston since the construction of the Town Hall in the 1850s”. The school contributes to the civic character of Townhead and exhibits a successful mix of Edwardian design motifs, neo-Baroque, ‘Queen Anne’ and Arts and Crafts features. Set within green grounds at the edge of the town, it also acts as a landmark against the sloping hill.

Property	Description	Local interest	Condition
	<p>Large Palladian window to central gable end, four flat roof dormers with symmetrical arrangement and designs. Courtyard arrangement to rear of central part, with tall retaining wall and protruding bling gable end. Symmetrical arrangement and designs of tall flat roof dormers (although one lost to a later extension) and central dual-pitched dormer to rear elevation with stone copings and kneelers.</p>	<p>Late 20th and 21st century extensions harmed the composition and character of the building but it remains easily readable.</p>

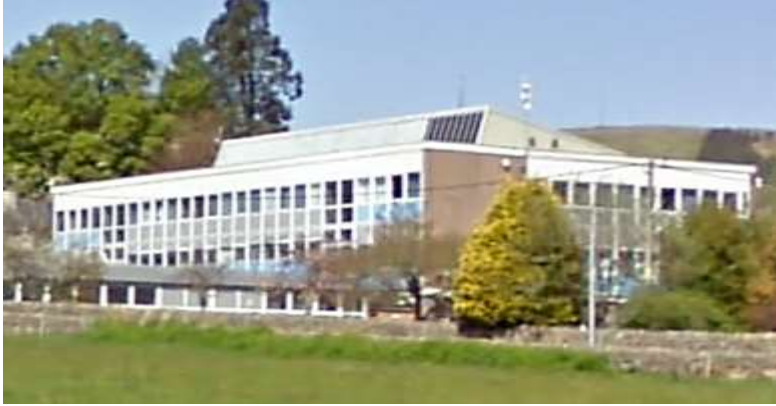
Property	Description	Local interest	Condition
Samuel King's School

<p>Secondary School, Cumberland County Architects under J.H. Haughan, 1957. Detached, rectangular plan with large central and inclined glazed roof dormer and wings on either side to west end, one of them later extended.</p>	<p>Architectural and historic interest: firmly of 1950s character, it is a well-preserved example of secondary schools of the period, and is a unique monument to post-war public development in Alston. Set within green grounds down the south-west part of the town, it also acts as a landmark with the conservation area and moors in the background.</p>	<p>Good.</p>

Property	Description	Local interest	Condition
	Three storeys, flat roof and curtain walls partly glazed with colours panels, partly clad with concrete brick-coloured panels. Flat roof canopy to main entrance at east end with glazed door and casement windows to side. Brick wall to right side of road elevation hiding plant or storage extension, main not be original.	The originality of its design was noted in Pevsner's Architectural Guides, "flat roof and glassy screen walls of the period, but an unusually deep plan to offer minimum external surface to the Pennine weather". Its architecture can be perceived as controversial, but its uniqueness contributes to its interest.

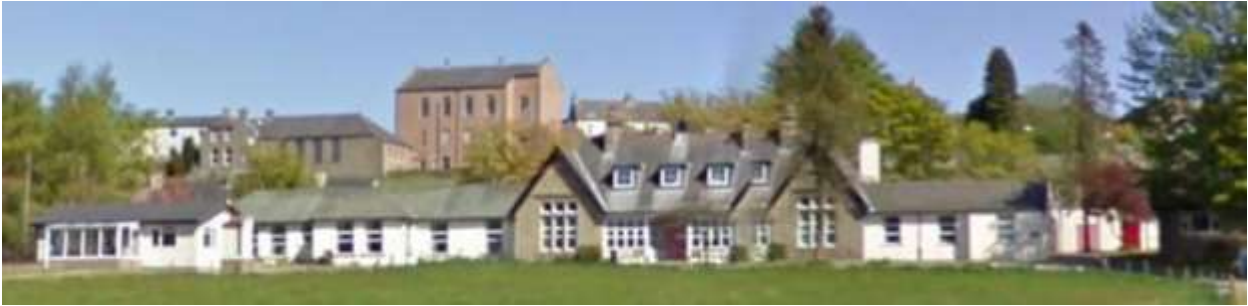
Property	Description	Local interest	Condition
Ruth Lancaster James Cottage Hospital

<p>Cottage hospital, by T. T. Scott, 1908. Detached, complex cross-gable linear plan, one main block with a 70 feet frontage and a two-storey administration block at the rear. Extended in 1929. Welsh slate dual pitched roof to front part (to west facing green grounds) and hipped roofs to north side and rear wings.</p>	<p>Architectural and historic interest: at the national level, it is typical in style and arrangement of a cottage hospital, offering a small number of beds arranged in single storey wards off a two-storey, mixed block, and with a traditional domestic character. It is nonetheless of a unique architecture in Alston, displays high quality in its design and materials,</p>	<p>Good.</p>

Property	Description	Local interest	Condition
	<p>Central part has decorative clay ridge tiles, symmetrical arrangement of four tall stone chimneys with one missing, above four flat roof dormers. Stone ashlar to central part with dripstone detailing and off-white rendered wings. Large recessed central entrance flanked by bay windows with multi-pane casements. Tall stone mullioned windows to central gable ends with multi-pane casements. Larger multi-panes to casements on side wings, and top- or bottom-hung casements on north side and rear wings. Later outbuildings not of interest.</p>	<p>which are well preserved. Set within green grounds down the south-west part of the town, it also acts as a landmark with the conservation area and moors in the background. Funded by subscription, it was part of a national movement of substantial investment in health started at the end of 19th century, and a crucial institution in Alston Moor, being isolated from the nearest general hospital. By 1938, the hospital was also being used as a maternity and child welfare centre. It is still used as a hospital, thus adding to its significance.</p>

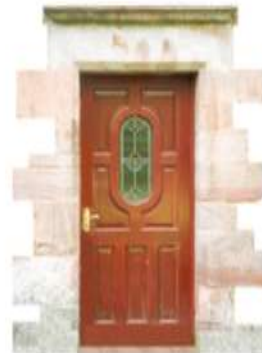
Examples of door designs to avoid, particularly in traditional properties

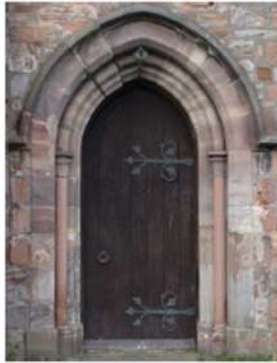
Examples of period doors
