# **Appleby Conservation Area Character Appraisal and Management Plan**

**June 2021**

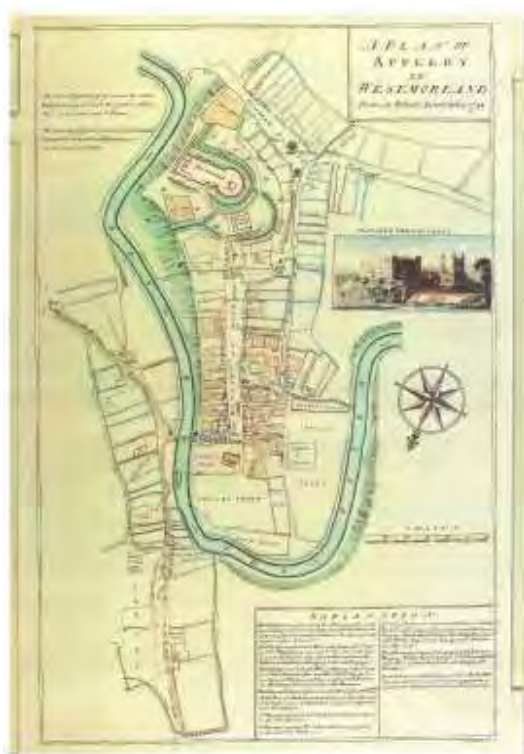
Figure 3 Detail from the 1754 Thanet electoral plan of Appleby (Cumbria Archive Centre, Carlisle, DLONS/L5/3/1/1/2, reproduced with kind permission by Jim Lowther in Appleby HAA)

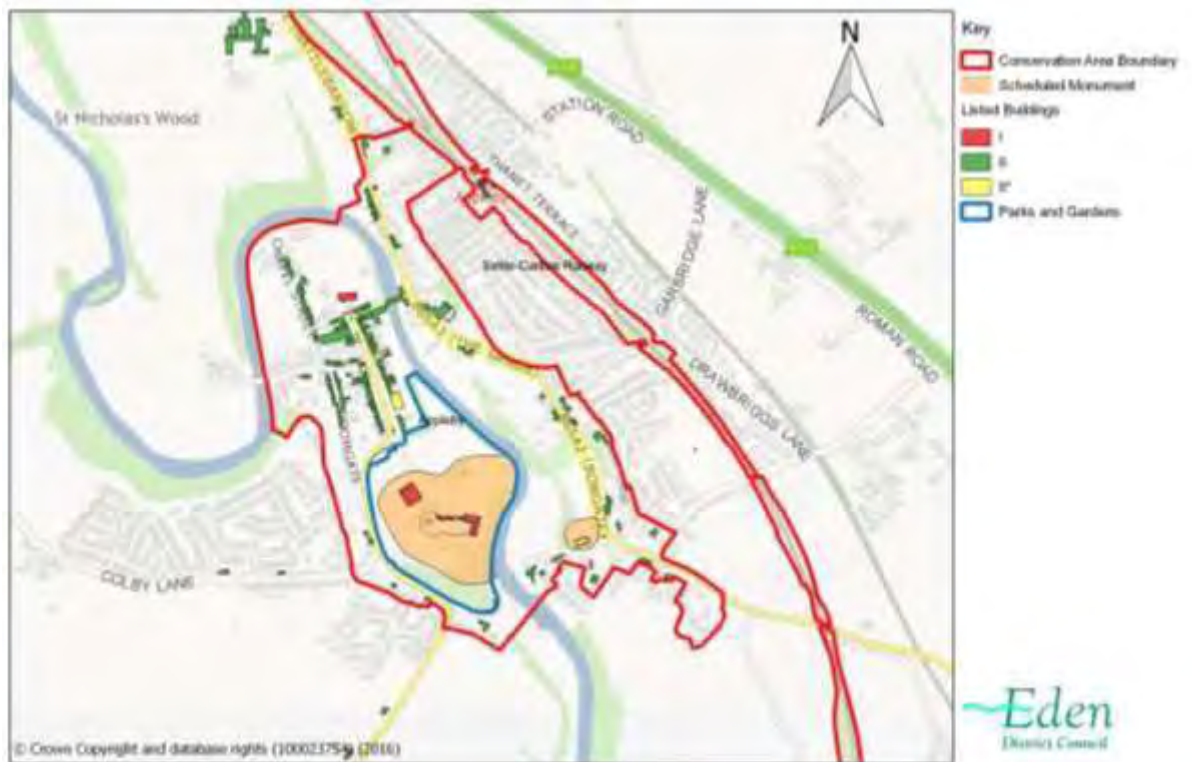
Figure 4 Heritage Assets

- 3.2.1 There are a total of two scheduled monuments, 183 listed buildings and structures and one registered park & garden found within the conservation area boundary, as shown on figure 4. The list descriptions for these designated assets are contained within appendix B along with notes about their present condition.

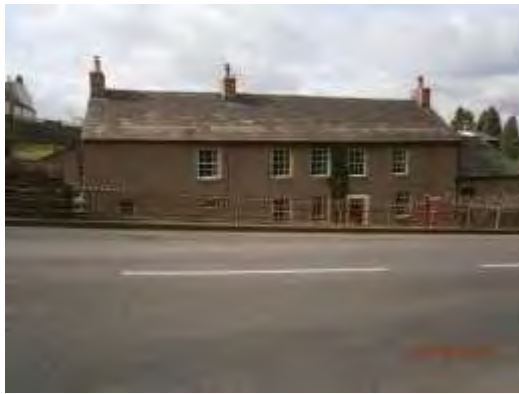
Figure 18 An 18th century longhouse (grade II)

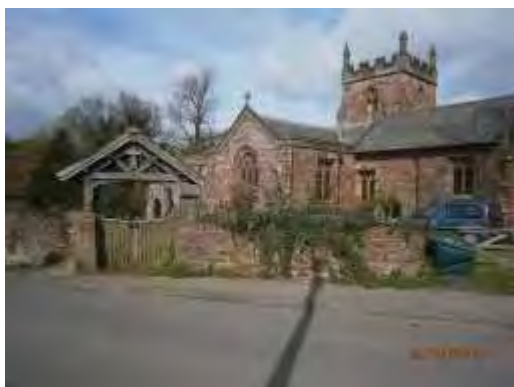
3.3.16 St Michael's church stands at the core of Bongate – at the junction of Bongate and Mill Hill. The sandstone wall surrounding the grounds to Courtfield Hotel (formerly a vicarage) incorporates architectural features relating to St Michael's Church prior to its remodelling in the 19<sup>th</sup> century. The junction is also home to the Appleby Boer war memorial which was recently designated in January 2019 as a grade II listed structure. The junction is currently dominated by parked cars and has potential to be enhanced as a landmark area.

Figure 20 St Michaels Church (Scheduled monument and Grade II\* Listed Building)

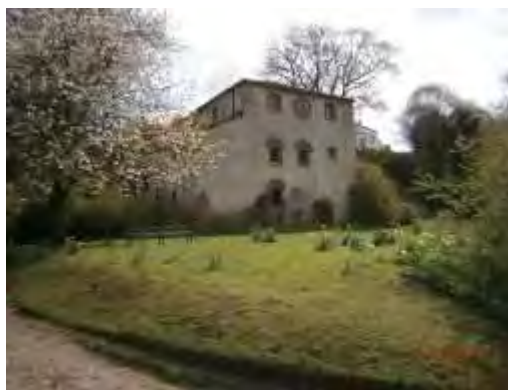
3.3.17 The river flows through the south west part of the area and provided power for Bongate Mill – the present Mill building is dated 1838 but likely replaced an earlier mill. The riverside here is now maintained public green space. Benches and an informal parking area have been created next to the Jubilee foot bridge and weir crossing that leads to Castle Park.

Figure 23 Bongate Mill (grade II)

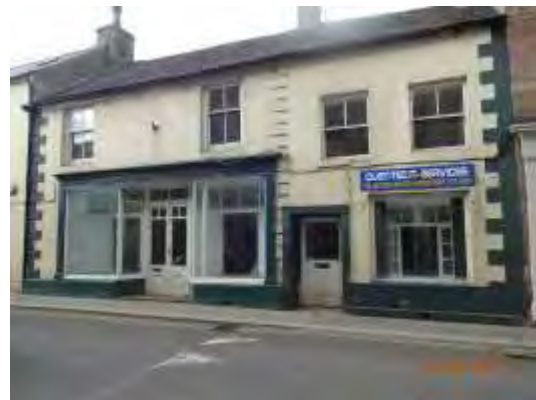
Figure 53 Vacant buildings requiring maintenance

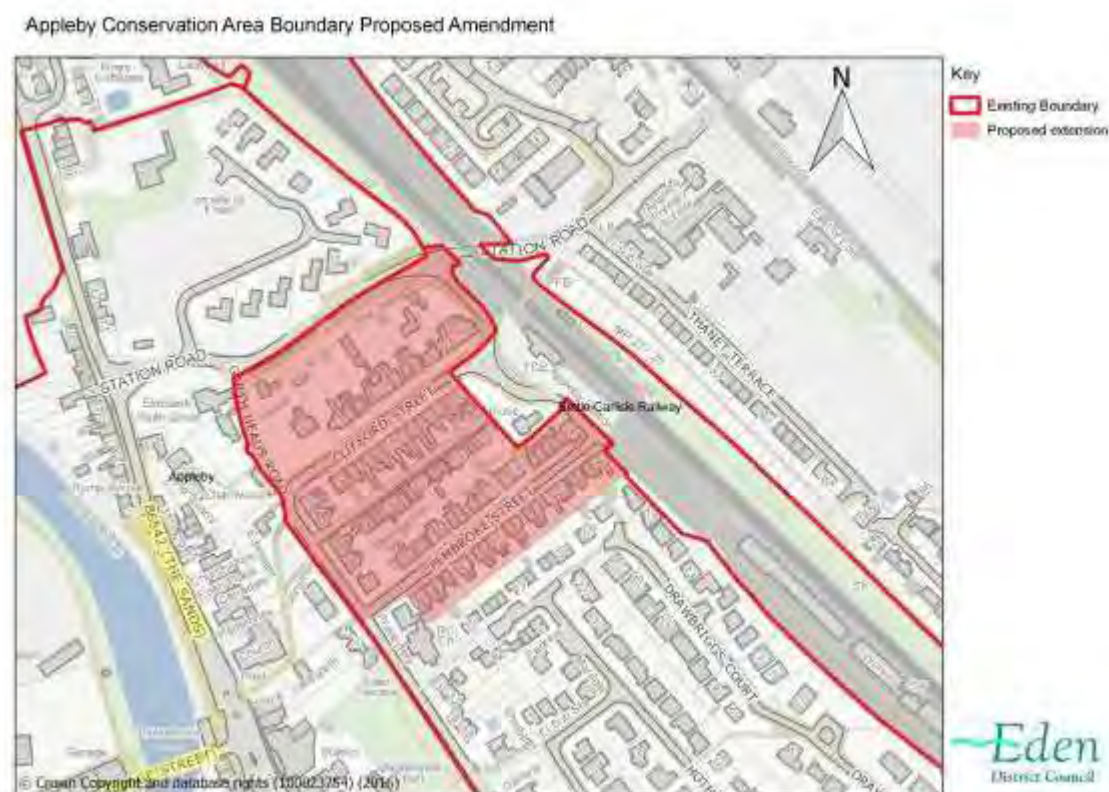
Figure 60 Proposed extension to the conservation area boundary

- 4.4.4 The decision to include the proposed extension is subject to the outcome of the public consultation being carried out between 11 October and 28 November 2021.
